Inspection report

Section Pictures - 4/1/2020 - 297

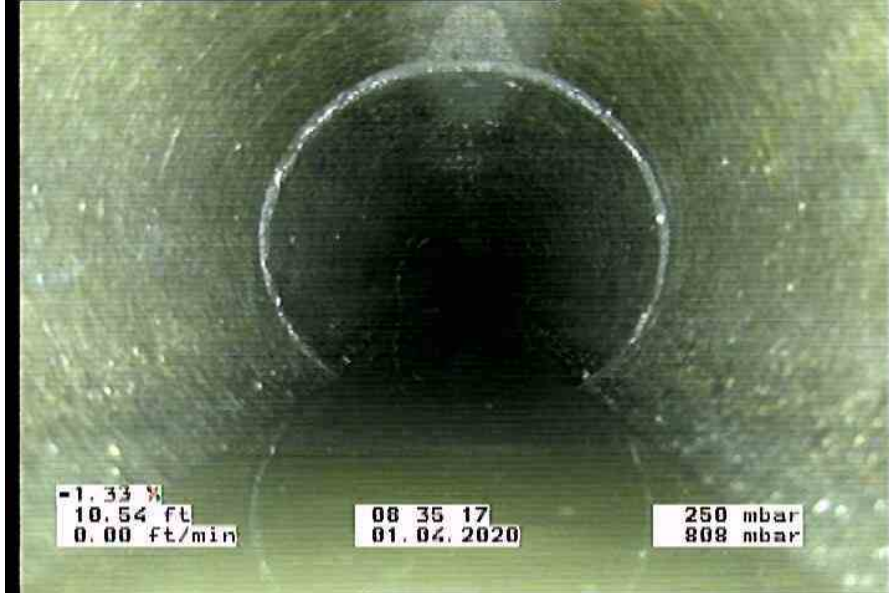
297_d008bb29-2bb9-4398-9bcc-6ca7ab575d7f_20200401_084001_202.jpg, 00:00:00, 0.00ft
Manhole

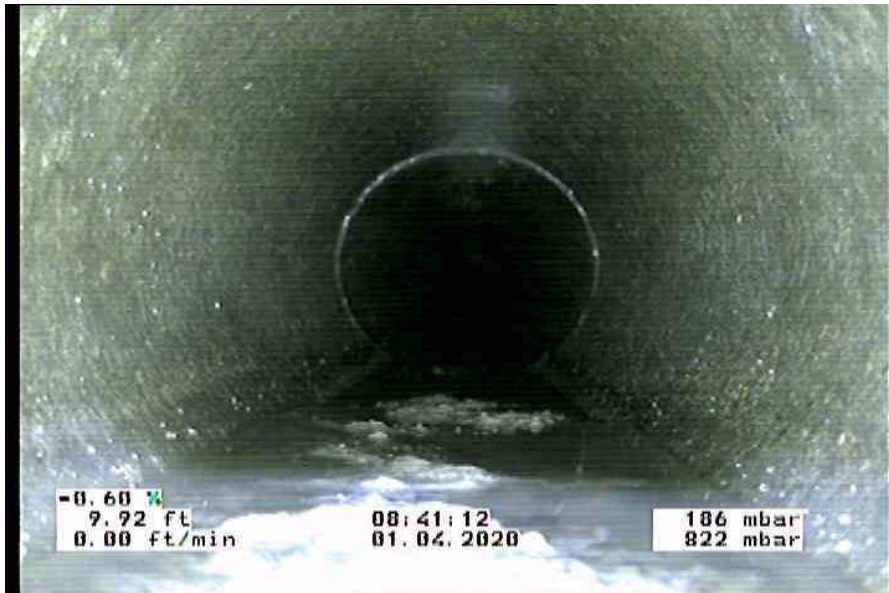
297_724ff749-2ddf-4bee-a7ff-cdeb8c31d9aa_20200401_084556_166.jpg, 00:04:59, 0.00ft
Water Level, 5% of the vertical dimension

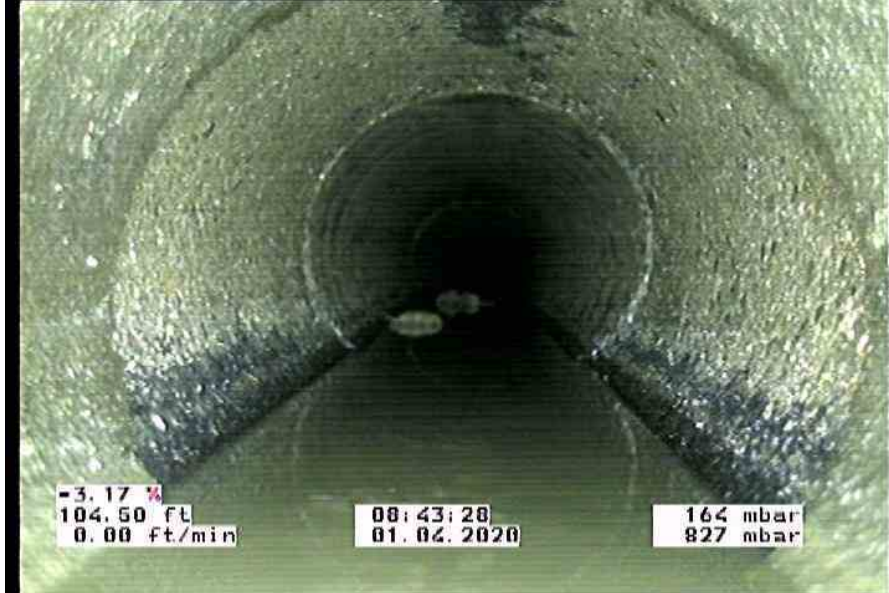
297_6b63931e-ebdd-416f-9d6e-738ecb9f1062_20200401_084812_087.jpg, 00:07:17, 104.50ft
Material Change, Concrete pipe (non reinforced)

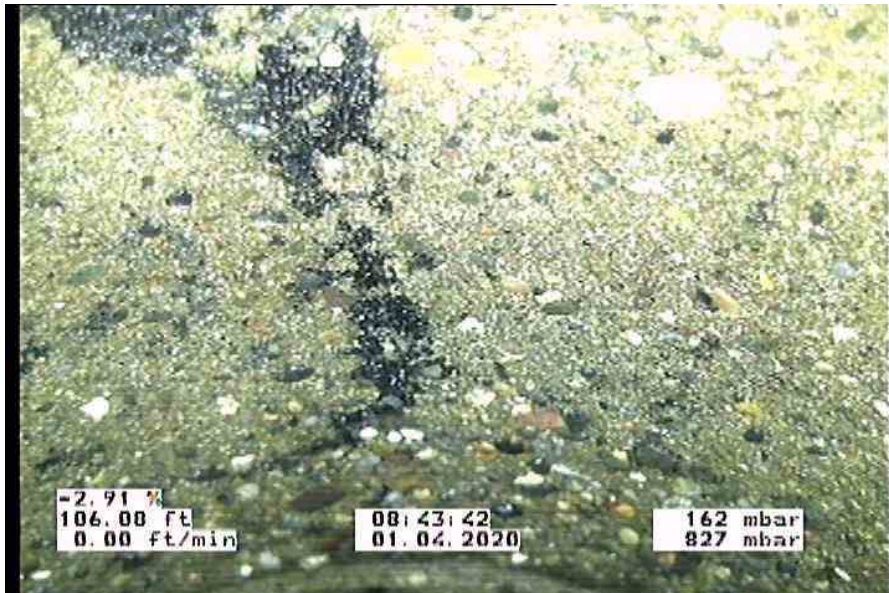
297_24bf6c94-8c3c-4a30-83bc-735eb4f0c968_20200401_084826_680.jpg, 00:07:17, 104.50ft
Material Change, Concrete pipe (non reinforced)

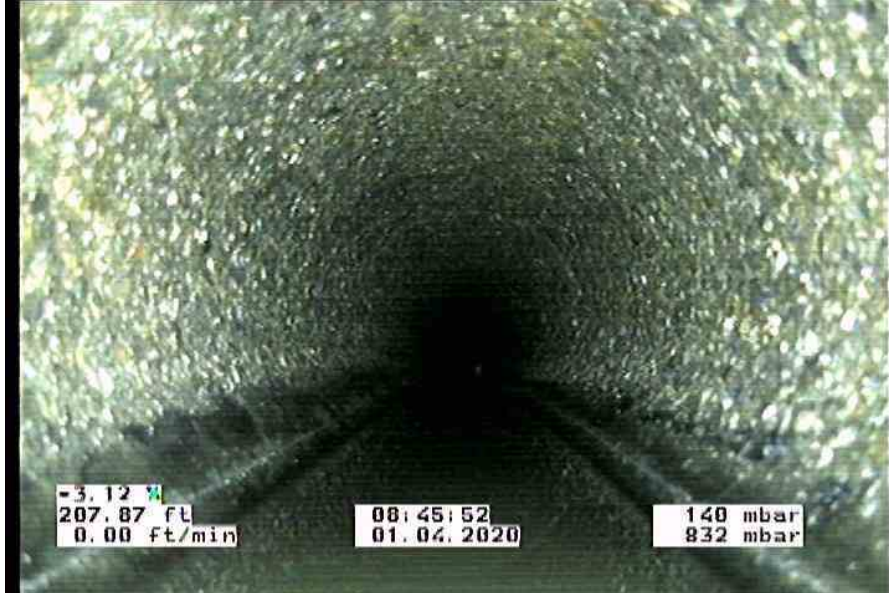
297_1d0c3abe-9945-4fad-9928-6c1ddb29e7_20200401_085036_916.jpg,00:09:41,207.87ft
General Photograph

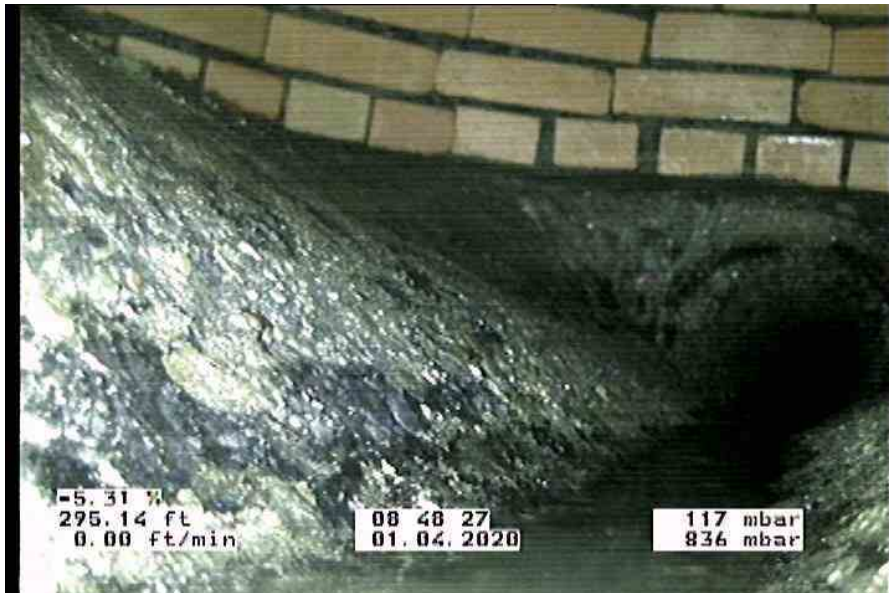
297_aa58ca28-abb8-429a-9c94-c33fbbba7cc6_20200401_085311_888.jpg,00:12:15,295.14ft
Manhole
