Inspection report

City: Montrose	Drainage Area:	Upstream MH: K10-3
Street: 313 Pine View	Media Label:	Up Rim to Invert: 0.0
Location Code:	Flow Control:	Downstream MH: K10-32
Location Details:	Sheet Number:	Down Rim to Invert: 0.0
Pipe shape: Circular	Sewer Use:	Total gallons used: 0.0
Pipe size: 8"	Sewer Category: SEC	Joints passed: 0
Pipe material: Concrete Segments (unbolted)	Purpose:	Joints failed: 0
Lining Method:	Owner:

Section Pictures - 7/15/2020 - 1843

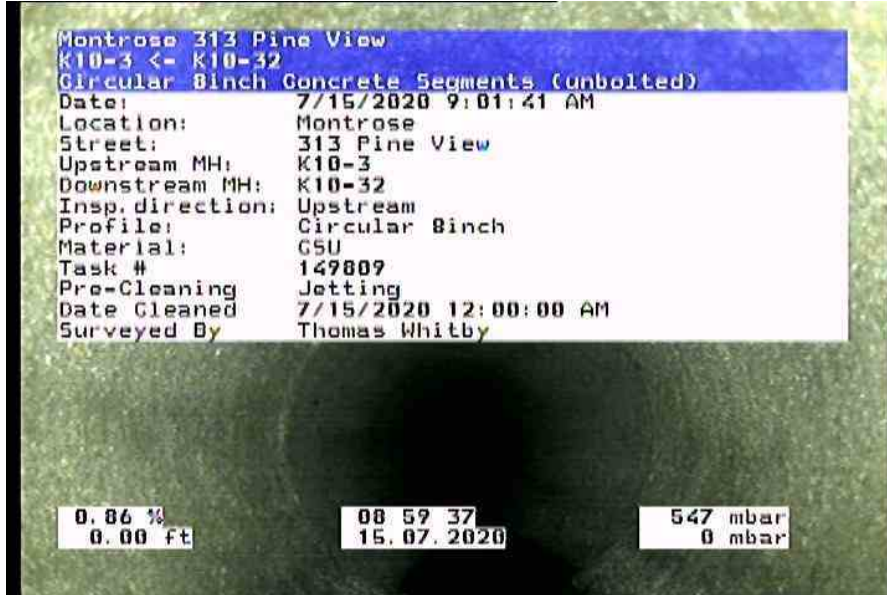
1843_fc005c85-a952-423c-8689-ea023056b1c3_20200715_090501_913.jpg, 00:00:23, 0.00ft Manhole

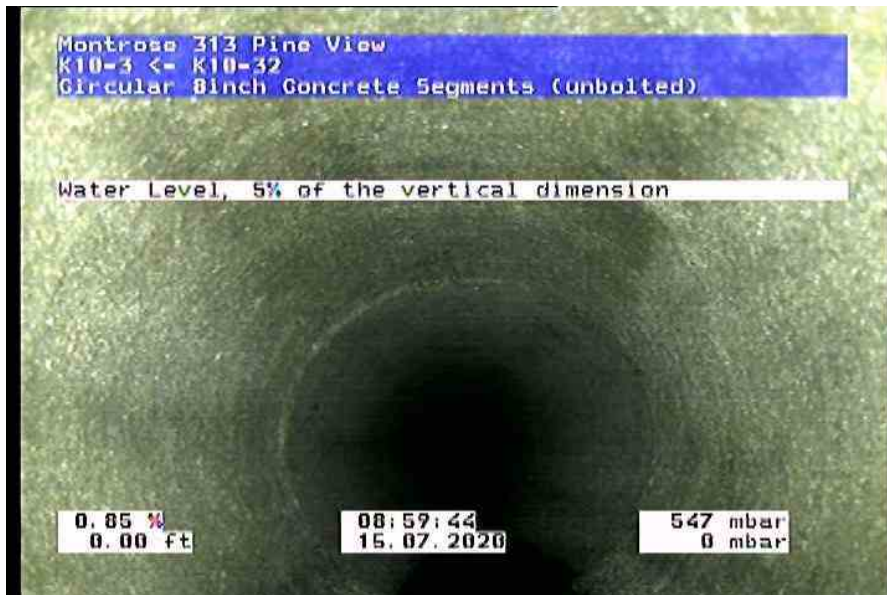
1843_bd4abb21-3a9c-4938-aa55-83841a3f67cd_20200715_090508_449.jpg, 00:00:34, 0.00ft Water Level, 5% of the vertical dimension

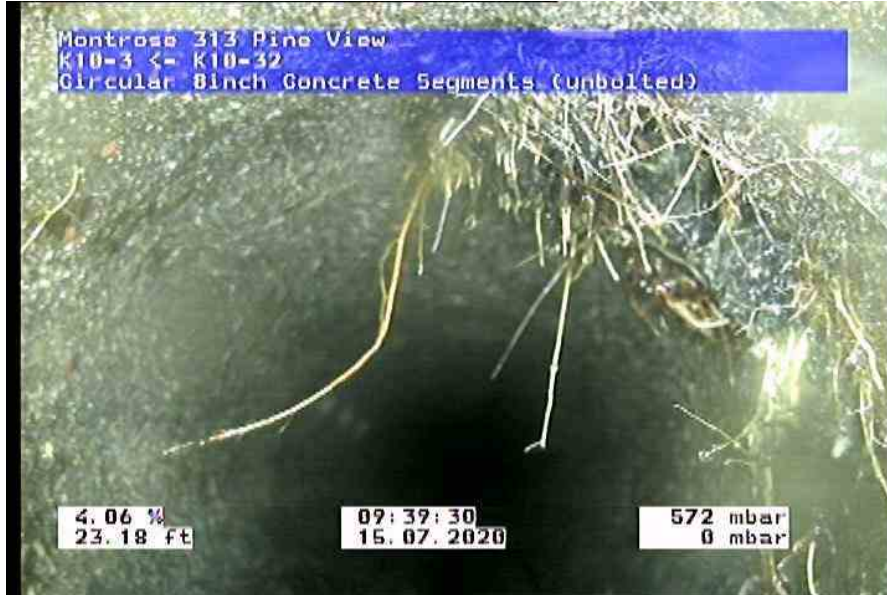
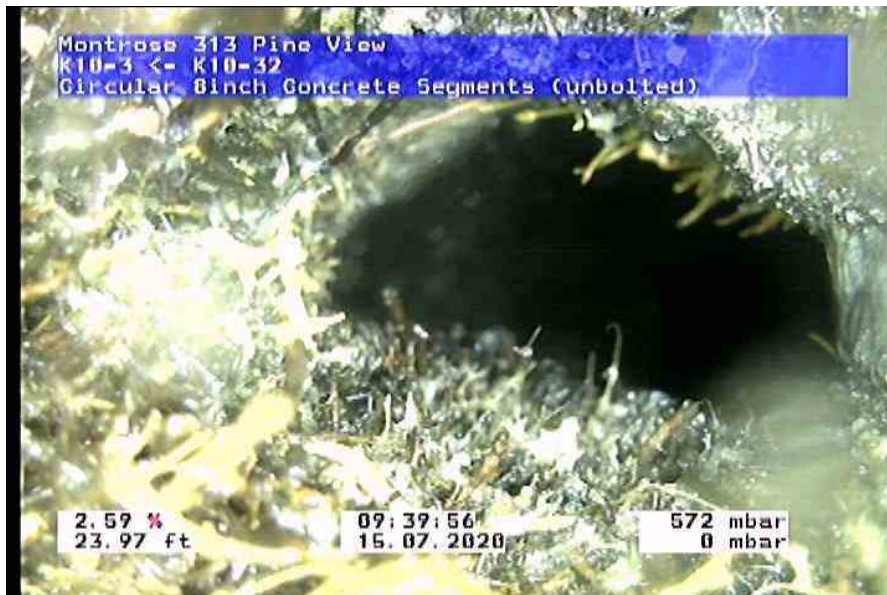
1843_9a42bb62-9566-4822-b6a5-bb8ed23d547d_20200715_094454_470.jpg, 00:04:37, 23.18ft
Tap Break-In Defective at 2 o'clock, 4inch dim

1843_5b901da6-cb23-41a4-b9b4-69754cc50892_20200715_094520_780.jpg, 00:04:37, 23.18ft
Tap Break-In Defective at 2 o'clock, 4inch dim

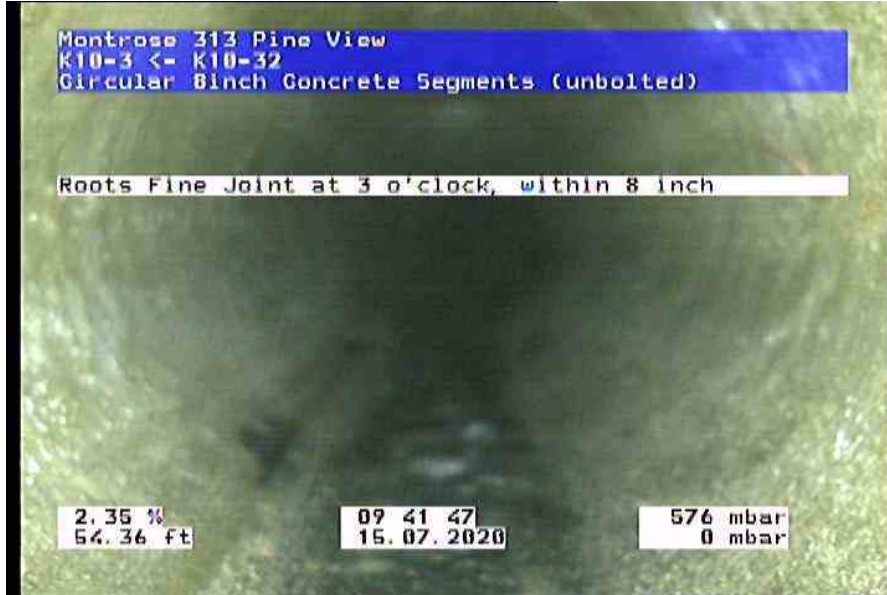
1843_242a7481-1aec-449f-935f-1e9734170bac_20200715_094712_201.jpg, 00:07:32, 54.36ft
Roots Fine Joint at 3 o'clock, within 8 inch

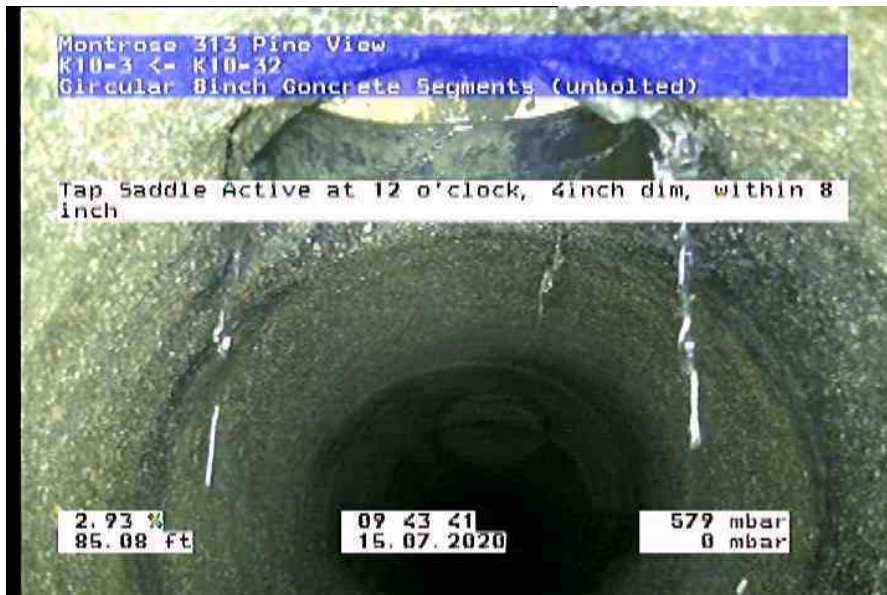
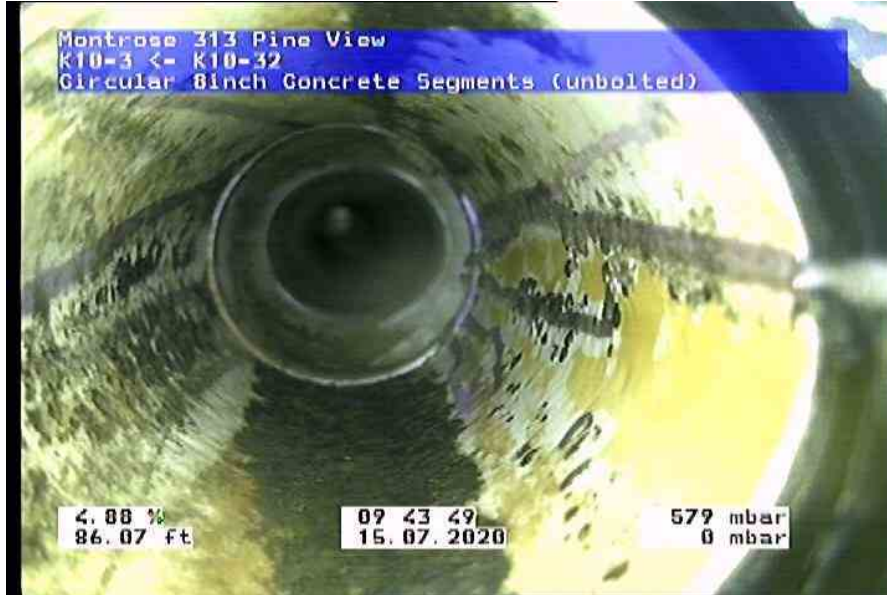
1843_c95d6925-9ad6-4c5a-9e48-1c2307ec5223_20200715_094905_596.jpg, 00:09:25, 85.08ft
Tap Saddle Active at 12 o'clock, 4inch dim, within 8 inch

1843_d406e683-6c12-4d23-8b24-3252ba16b479_20200715_094914_420.jpg, 00:09:25, 85.08ft
Tap Saddle Active at 12 o'clock, 4inch dim, within 8 inch

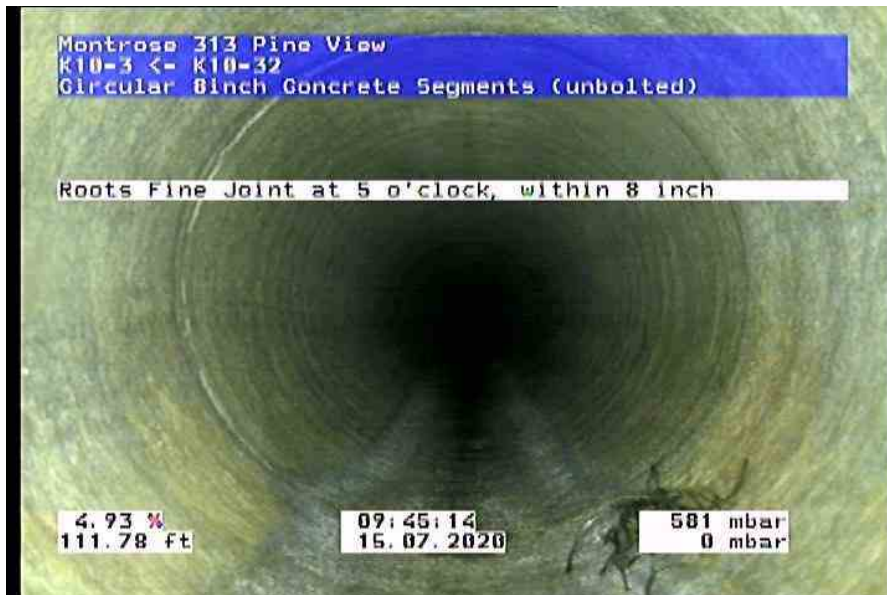
1843_50bb3915-6189-477e-a763-f1da52e855b5_20200715_095038_549.jpg, 00:10:58, 111.78ft
Roots Fine Joint at 5 o'clock, within 8 inch

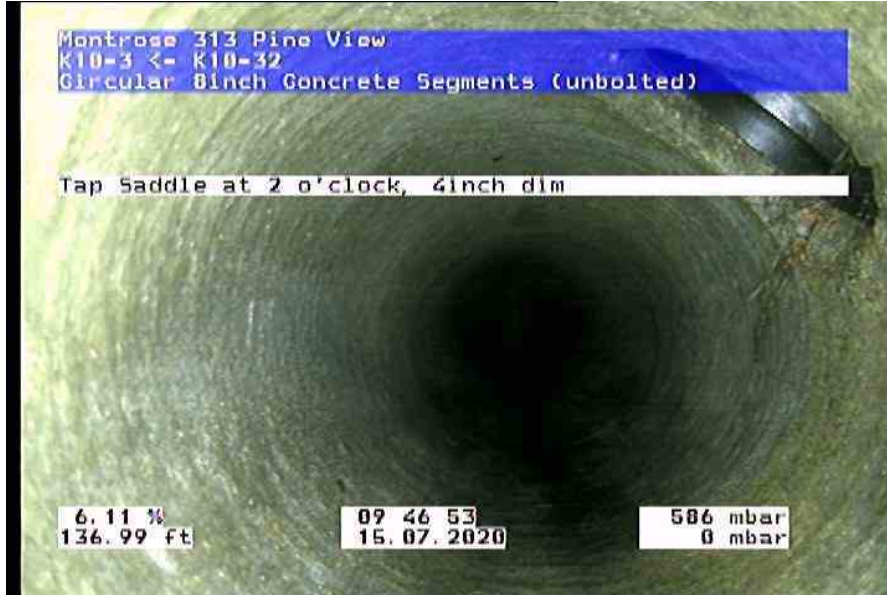
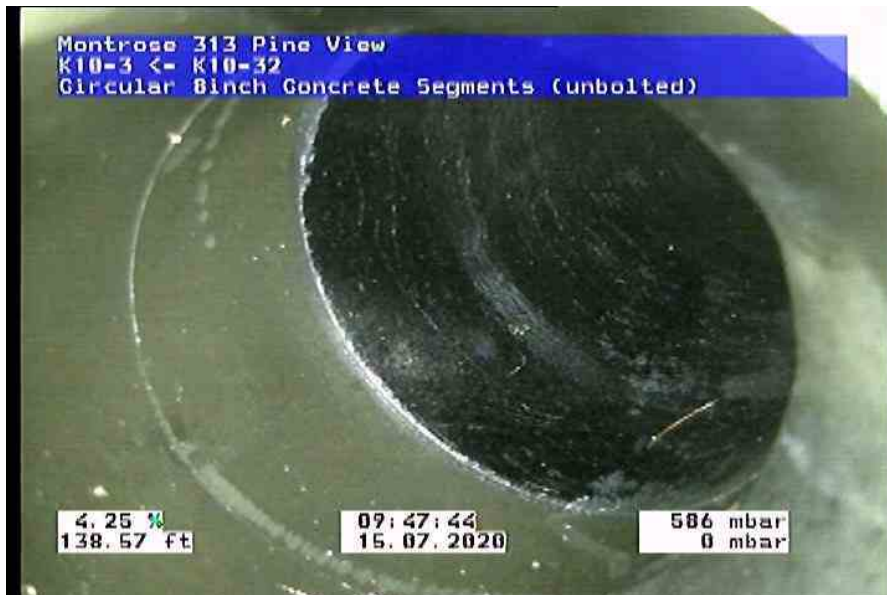
1843_97c3694a-8b59-419c-81d9-3efe309963b3_20200715_095217_504.jpg, 00:12:37, 136.99ft
Tap Saddle at 2 o'clock, 4inch dim

1843_1d5c3e9c-7aba-4272-aa50-c52371ee656e_20200715_095308_997.jpg, 00:12:37,
136.99ft
Tap Saddle at 2 o'clock, 4inch dim

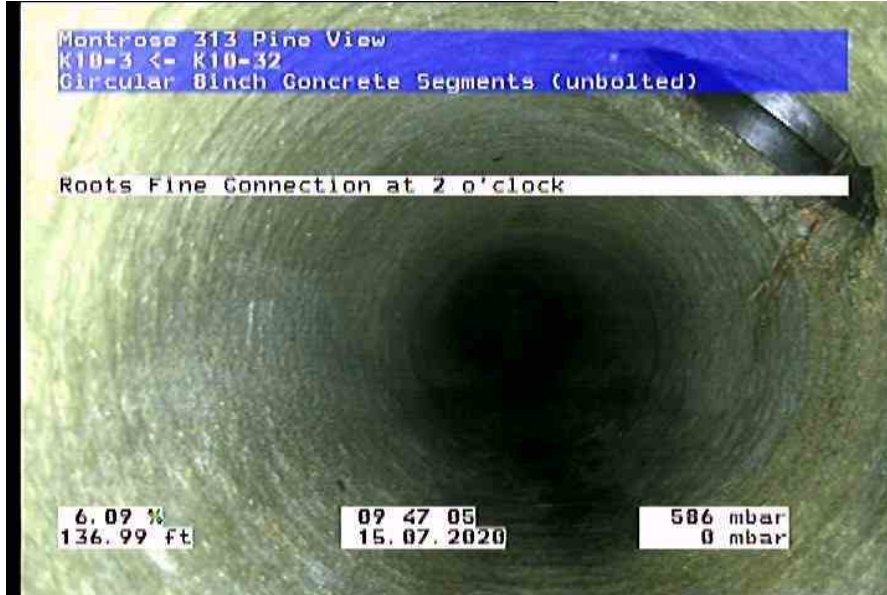
1843_e8323419-8eb3-40a8-bbd8-aa6301419261_20200715_095229_764.jpg, 00:12:50, 136.99ft
Roots Fine Connection at 2 o'clock

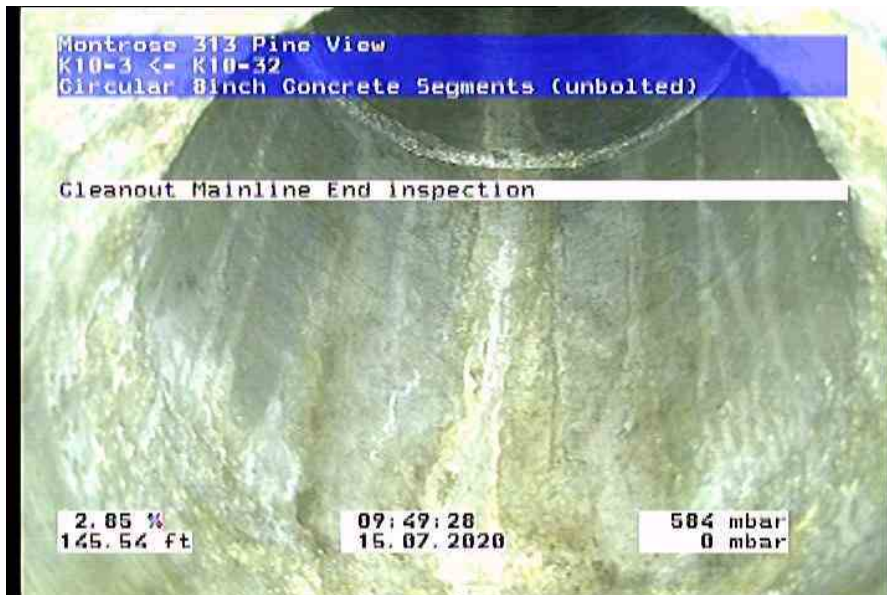
1843_930ce9b3-5e1d-4c46-aa2e-9cb4eb2c4d7c_20200715_095452_941.jpg, 00:15:12, 145.54ft
Cleanout Mainline

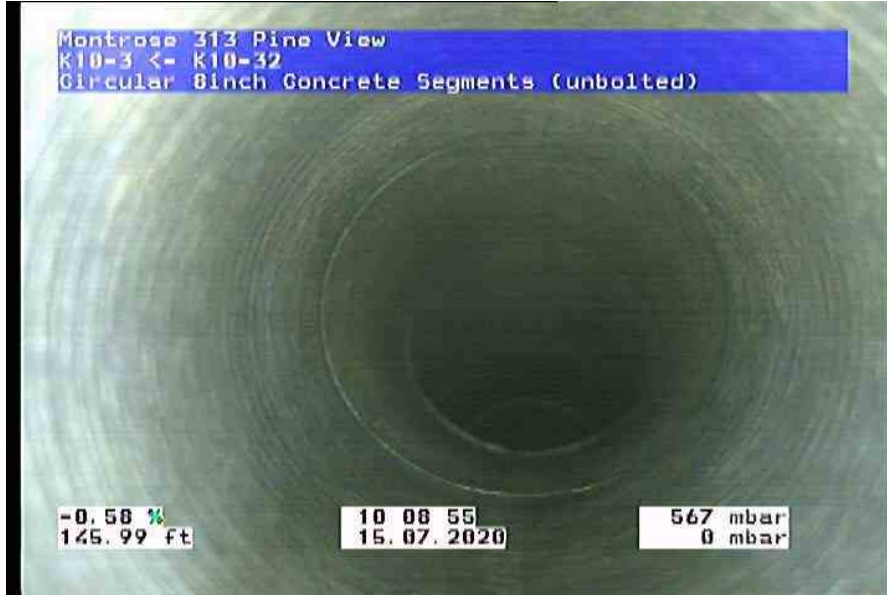
1843_88fb5202-8fa4-4720-a7c7-24b0b14790df_20200715_101419_747.jpg, 00:15:12, 145.54ft
Cleanout/Mainline
