## Inspection report

Date: <b>7/15/2020</b>	Work Order:	Weather:	Surveyed By: <b>Thomas Whitby</b>	Certificate Number: <b>U-217-07006886</b>	Pipe Segment Ref.: <b>2228</b>
Year laid:	Pre-cleaning:	Direction: <b>Downstream</b>	Pipe Joint Length:	Total Length: <b>392.3'</b>	Length Surveyed: <b>392.3'</b>

City: <b>Montrose</b>	Drainage Area:	Upstream MH: <b>K10-32</b>
Street: <b>303 Pine View Dr</b>	Media Label:	Up Rim to Invert: <b>0.0</b>
Location Code:	Flow Control:	Downstream MH: <b>K10-30</b>
Location Details:	Sheet Number:	Down Rim to Invert: <b>0.0</b>
Pipe shape: <b>Circular</b>	Sewer Use:	Total gallons used: <b>0.0</b>
Pipe size: <b>8"</b>	Sewer Category: <b>SEC</b>	Joints passed: <b>0</b>
Pipe material: <b>Concrete Segments (unbolted)</b>	Purpose:	Joints failed: <b>0</b>
Lining Method:	Owner:

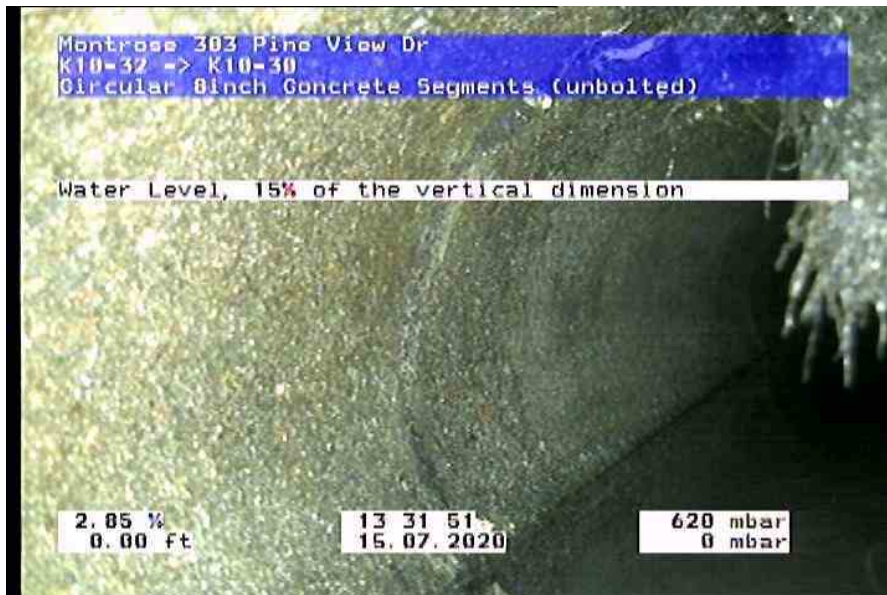
2228\_e53a7f1e-6a39-4ca0-87ec-dc04e11d0523\_20200715\_133714\_820.jpg, 00:01:37, 0.00ft Water Level, 15% of the vertical dimension

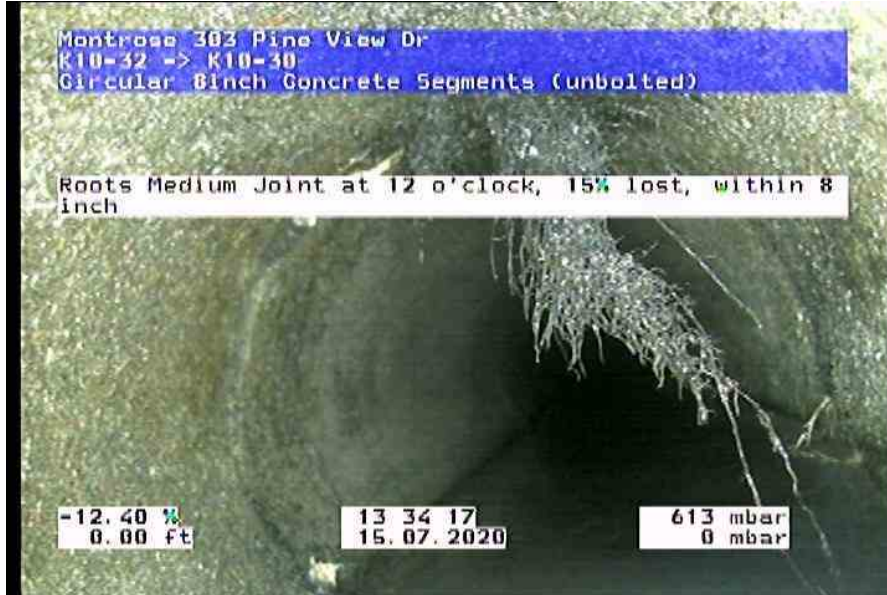
0.00	RMJ	Roots Medium Joint at 12 o'clock, 15% lost, within 8 inch	00:04:03		M3
	22.24	S01	MWLS Water Level, Sag in pipe, 75% of the vertical dimension, Start	00:05:27

2228\_51ffa686-4aab-4f44-b41b-f2d858aa5581\_20200715\_133941\_318.jpg, 00:04:03, 0.00ft  
Roots Medium Joint at 12 o'clock, 15% lost, within 8 inch

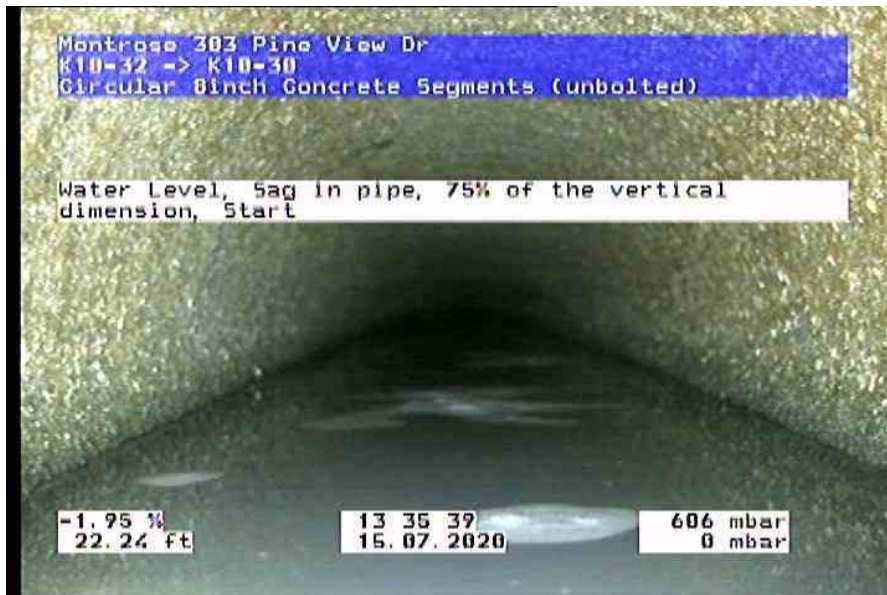
2228\_04a1fd56-3379-4f69-ac94-100553f8bd91\_20200715\_134103\_267.jpg, 00:05:27, 22.24ft  
Water Level, Sag in pipe, 75% of the vertical dimension, Start

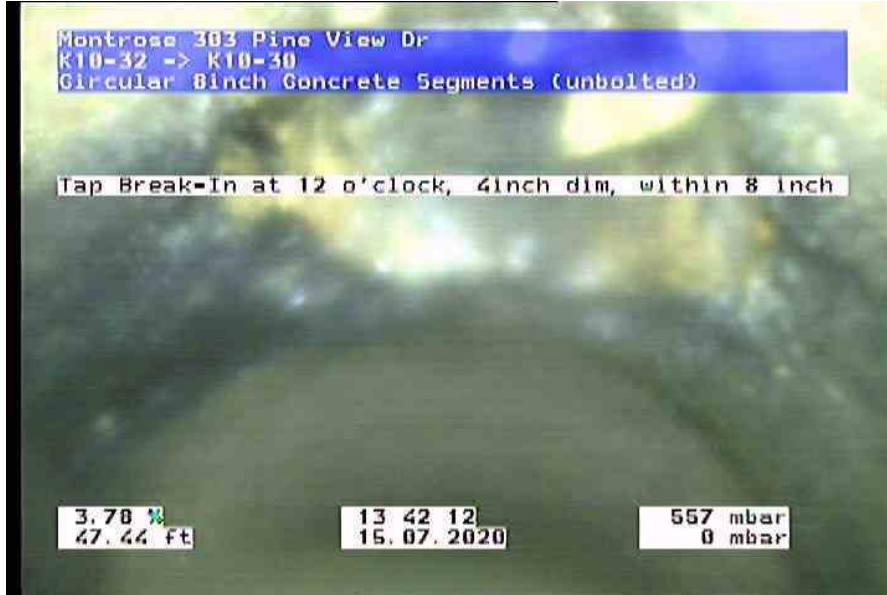
2228\_2dbd9bcb-5e02-401b-99bb-f47ce28bdac8\_20200715\_134736\_863.jpg, 00:12:00, 47.44ft  
Tap Break-In at 12 o'clock, 4inch dim, within 8 inch

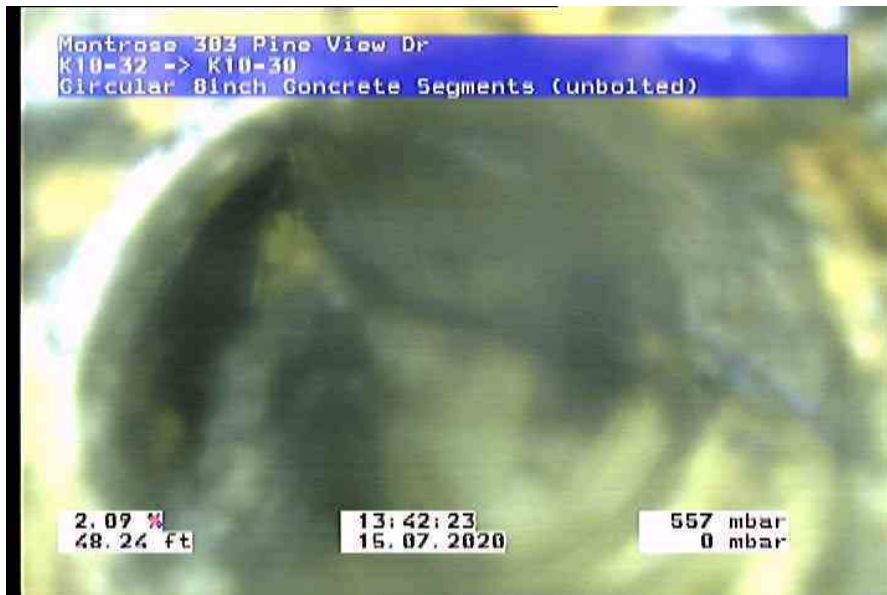
2228\_62f267f0-a545-457f-817c-58232b37ebe6\_20200715\_134748\_212.jpg, 00:12:00, 47.44ft  
Tap Break-In at 12 o'clock, 4inch dim, within 8 inch

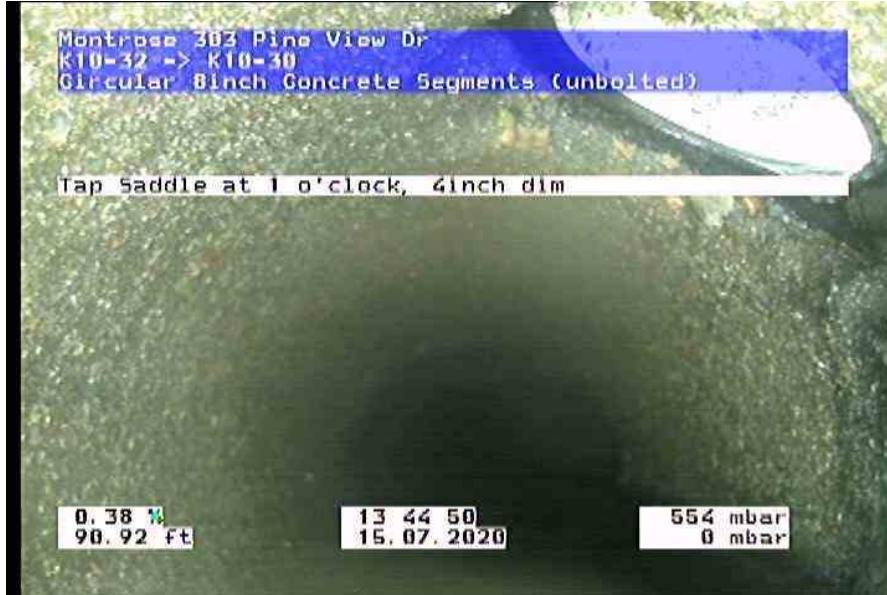
2228\_99ba0852-de46-4062-a44f-7c0fef3b7eec\_20200715\_135014\_771.jpg, 00:14:38, 90.92ft  
Tap Saddle at 1 o'clock, 4inch dim

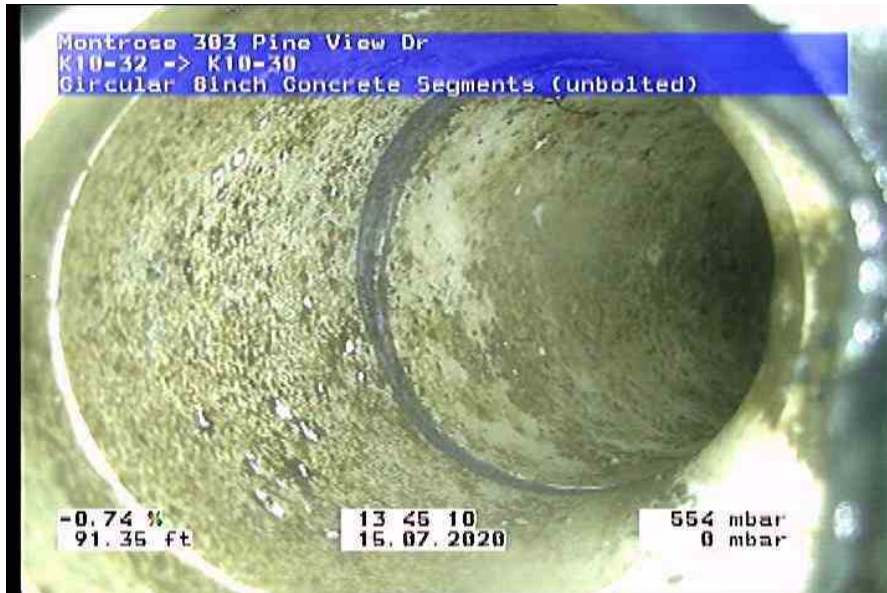
2228\_82e42b2b-548a-4636-84be-03c1deecfad\_20200715\_135035\_057.jpg, 00:14:38, 90.92ft  
Tap Saddle at 1 o'clock, 4inch dim

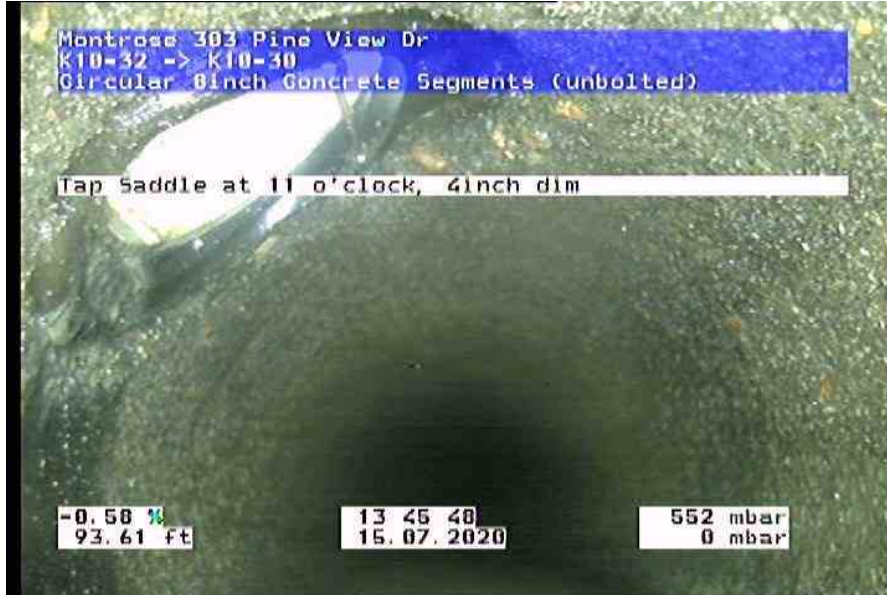
2228\_72d1972b-75ff-4086-8dc5-e230b10f25c8\_20200715\_135112\_731.jpg, 00:15:36, 93.61ft  
Tap Saddle at 11 o'clock, 4inch dim

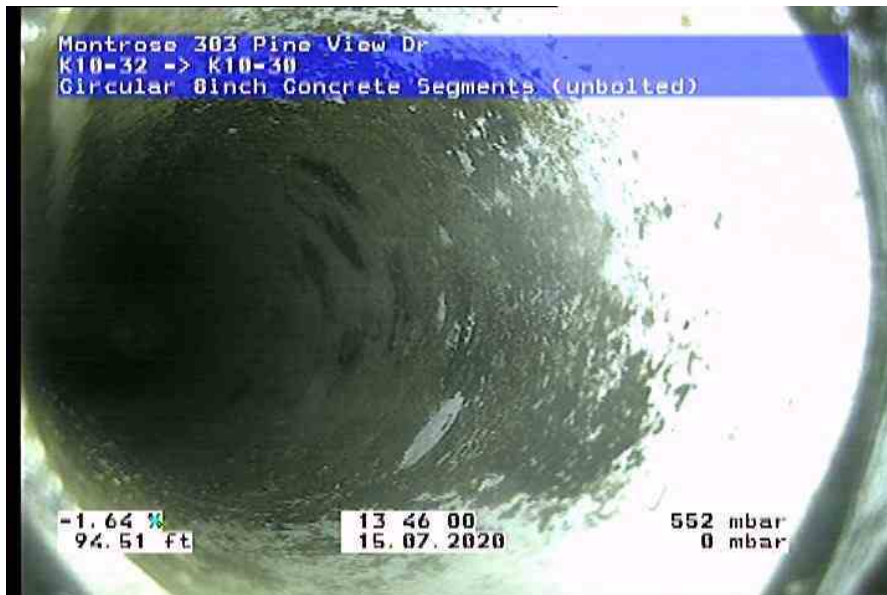
2228\_b72f6a17-5c34-46ca-84f9-cf57fb2e9347\_20200715\_135124\_593.jpg, 00:15:36, 93.61ft  
Tap Saddle at 11 o'clock, 4inch dim

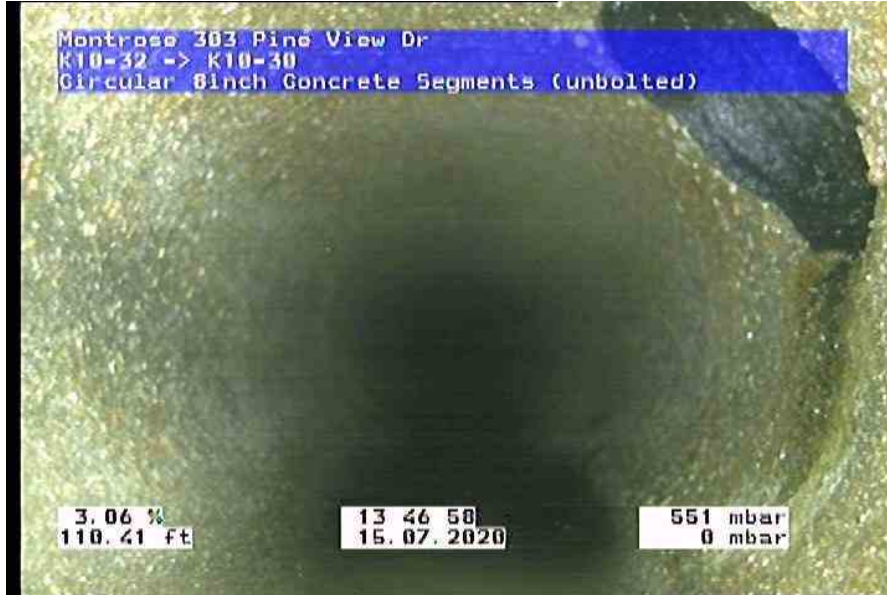
2228\_143280a6-1a0a-47d7-871c-b024ee0b3055\_20200715\_135222\_709.jpg, 00:16:37, 110.41ft  
Tap Break-In at 2 o'clock, 4inch dim

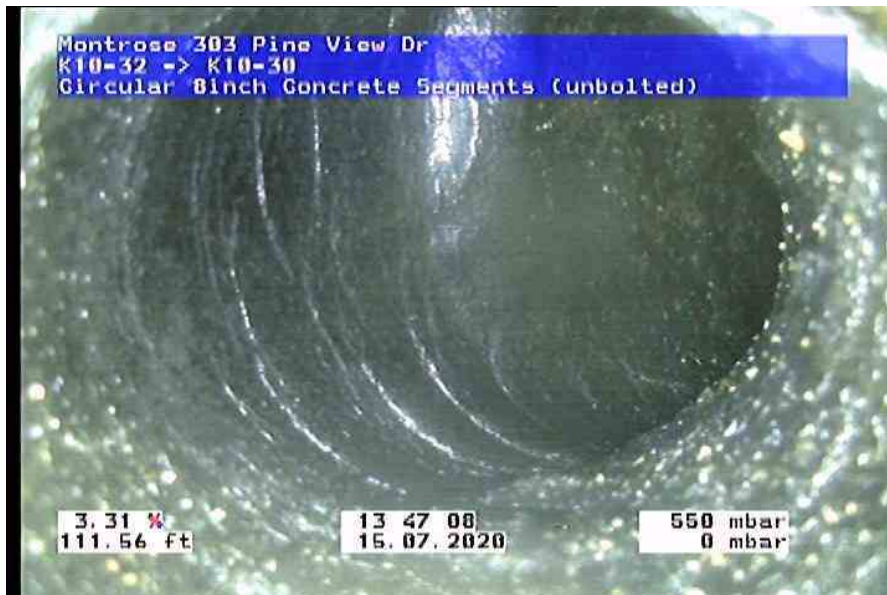
2228\_19d856d2-ffb4-4093-a5b3-7435951c7bca\_20200715\_135232\_814.jpg, 00:16:37, 110.41ft  
Tap Break-In at 2 o'clock, 4inch dim

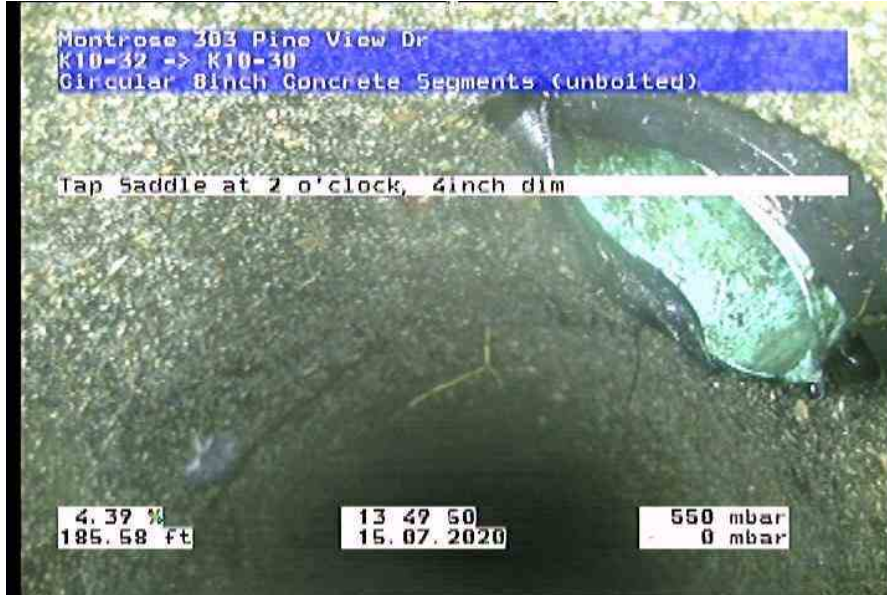
2228\_dbf51b7f-7b05-4133-9008-7e1feaa3a52f\_20200715\_135514\_267.jpg, 00:19:38, 185.58ft  
Tap Saddle at 2 o'clock, 4inch dim

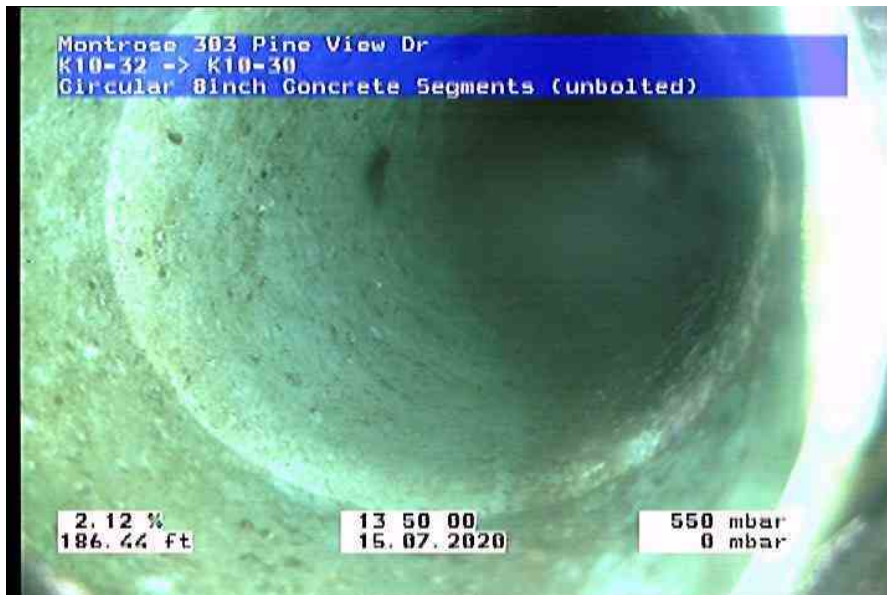
2228\_b4cf392b-cdc8-4e1b-ade7-98a0b1d6391a\_20200715\_135524\_453.jpg, 00:19:38, 185.58ft  
Tap Saddle at 2 o'clock, 4inch dim

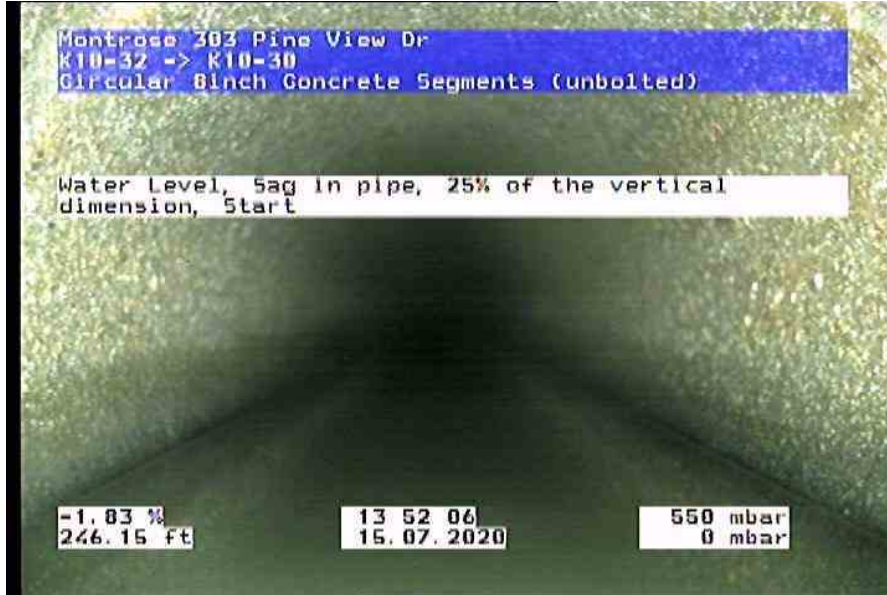
2228\_b5ab8652-b41e-49a4-885c-b8cb8b897273\_20200715\_135730\_358.jpg, 00:21:54, 246.15ft  
Water Level, Sag in pipe, 25% of the vertical dimension, Start

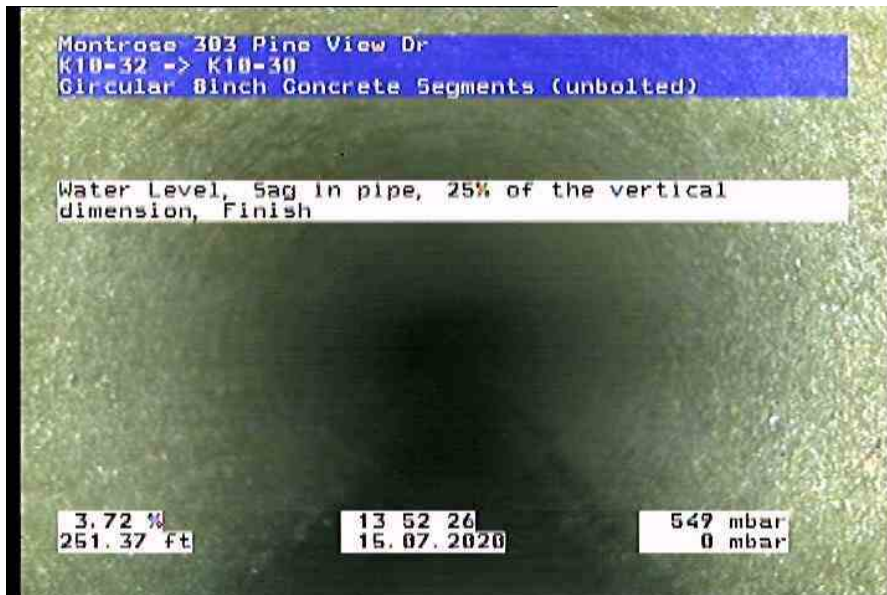
2228\_af8e0d99-17f3-452d-94d7-e15e95241195\_20200715\_135750\_899.jpg, 00:22:15, 251.37ft  
Water Level, Sag in pipe, 25% of the vertical dimension, Finish

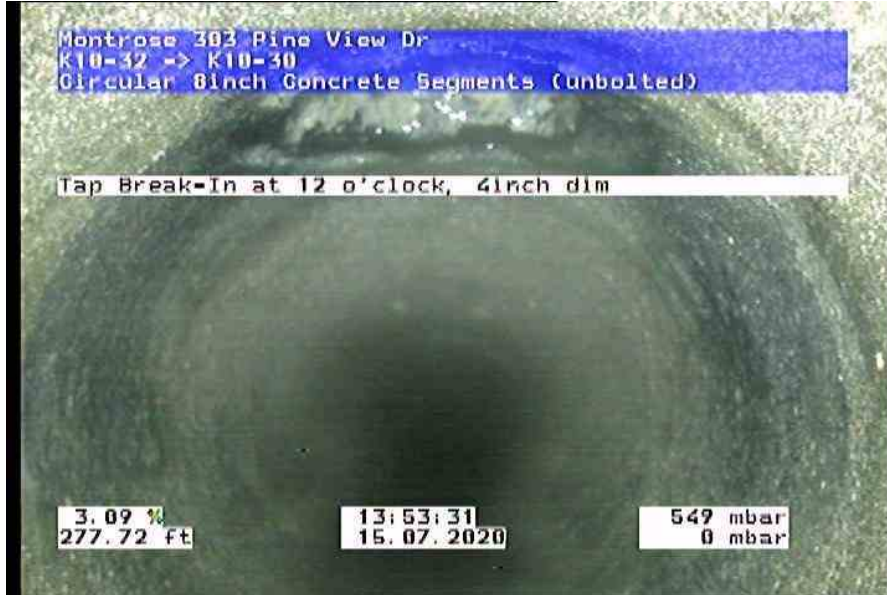
2228\_ca9c11ed-dbf4-47a3-bb99-549f4b9cb6a7\_20200715\_135855\_770.jpg, 00:23:20, 277.72ft  
Tap Break-In at 12 o'clock, 4inch dim

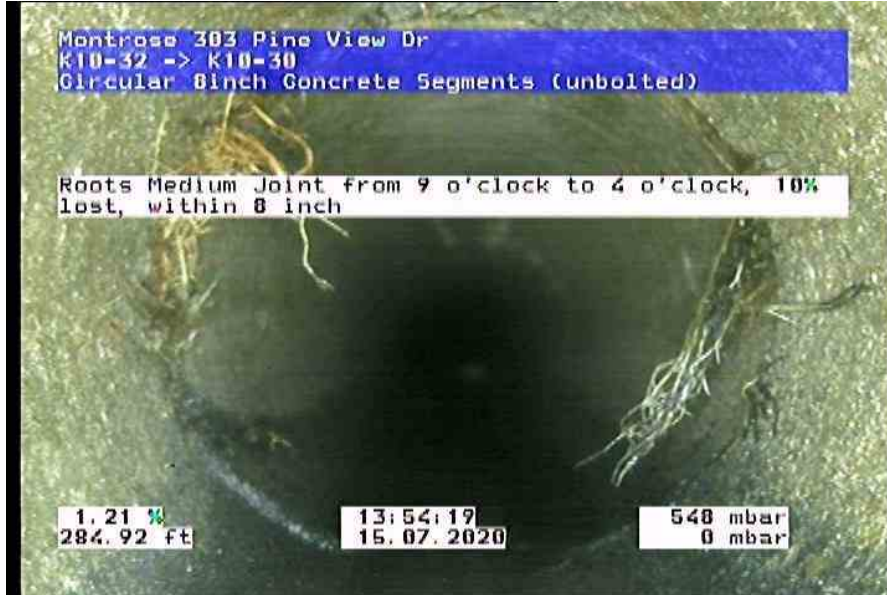
284.92	RMJ	Roots Medium Joint from 9 o'clock to 4 o'clock, 10% lost, within 8 inch	00:24:07		M3

2228\_ab9907ea-eb6a-4646-a853-5d6d51be4a70\_20200715\_135943\_645.jpg,00:24:07,  
284.92ft  
Roots Medium Joint from 9 o'clock to 4 o'clock, 10% lost, within 8 inch

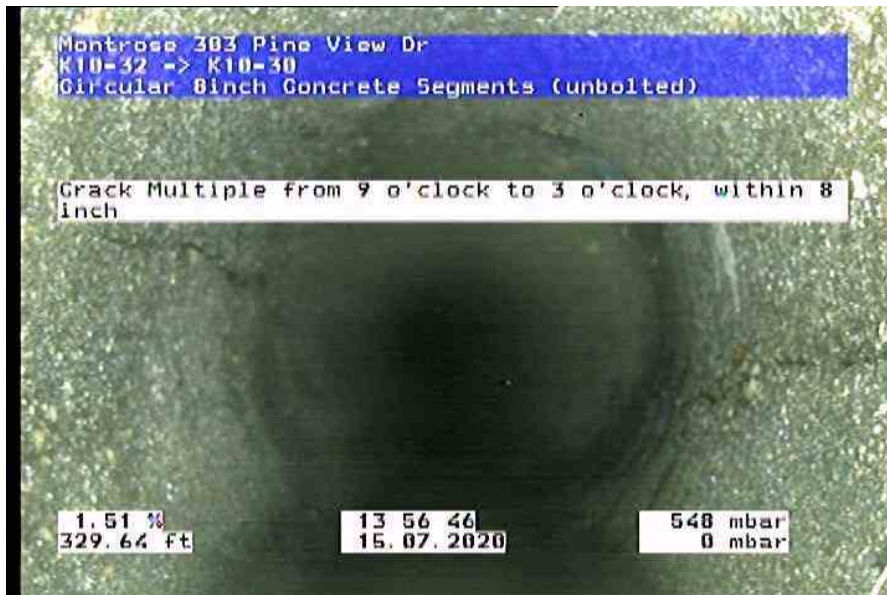
1:2320	Distance	Code	Observation	Counter	Photo	Grade	
	<u>329.64</u>	CM	Crack Multiple from 9 o'clock to 3 o'clock, within 8 inch	00:26:35		S3	
	<u>330.76</u>	TB	Tap Break-In at 1 o'clock, 4inch dim, within 8 inch	00:27:15			
	<u>351.24</u>	S04 MWLS	Water Level, Sag in pipe, 30% of the vertical dimension, Start	00:28:40			
	<u>359.27</u>	F04 MWLS	Water Level, Sag in pipe, 30% of the vertical dimension, Finish	00:29:21		S2	
	<u>363.65</u>	RFJ	Roots Fine Joint from 10 o'clock to 2 o'clock, within 8 inch	00:29:49		M1	
	<u>392.28</u>	AMH	Manhole / End Inspection	00:30:50			
QSR	QMR	SPR	MPR	OPR	SPRI	MPRI	OPRI
4431	4132	25.0	11.0	36.0	3.1	2.8	3.0

2228\_a44f2908-a759-4ed5-8667-4e5d0e5d63cb\_20200715\_140211\_021.jpg,00:26:35,329.64ft  
Crack Multiple from 9 o'clock to 3 o'clock, within 8 inch

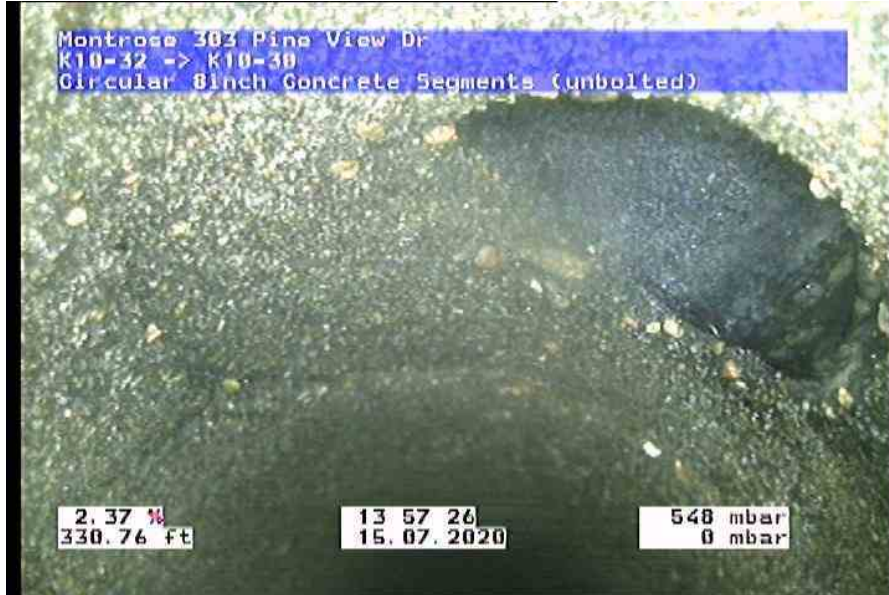
2228\_727aeaf4-5976-4fad-988b-c57f114d482c\_20200715\_140250\_745.jpg, 00:27:15, 330.76ft  
Tap Break-In at 1 o'clock, 4inch dim, within 8 inch

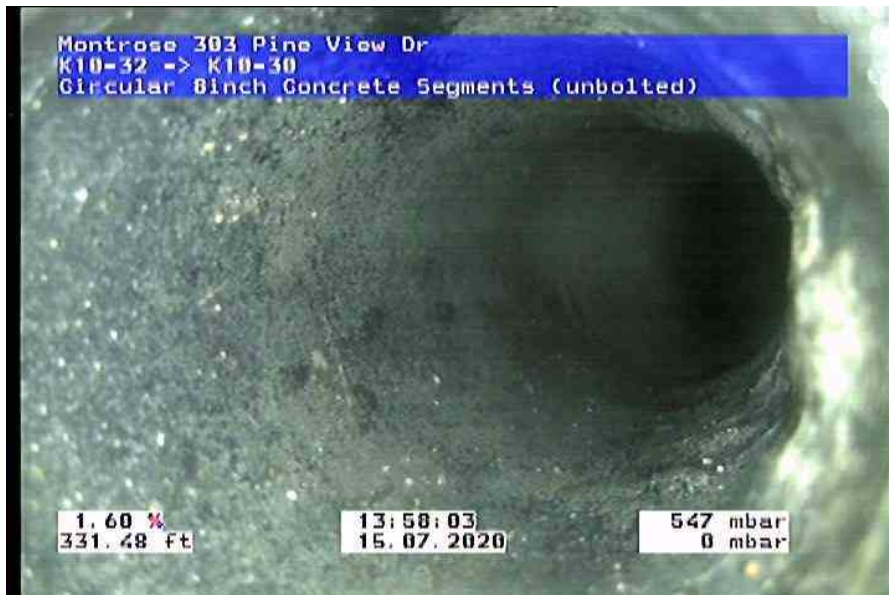
2228\_2ecd7da6-1cf9-401b-951b-8c06611d8e08\_20200715\_140328\_184.jpg, 00:27:15, 330.76ft  
Tap Break-In at 1 o'clock, 4inch dim, within 8 inch

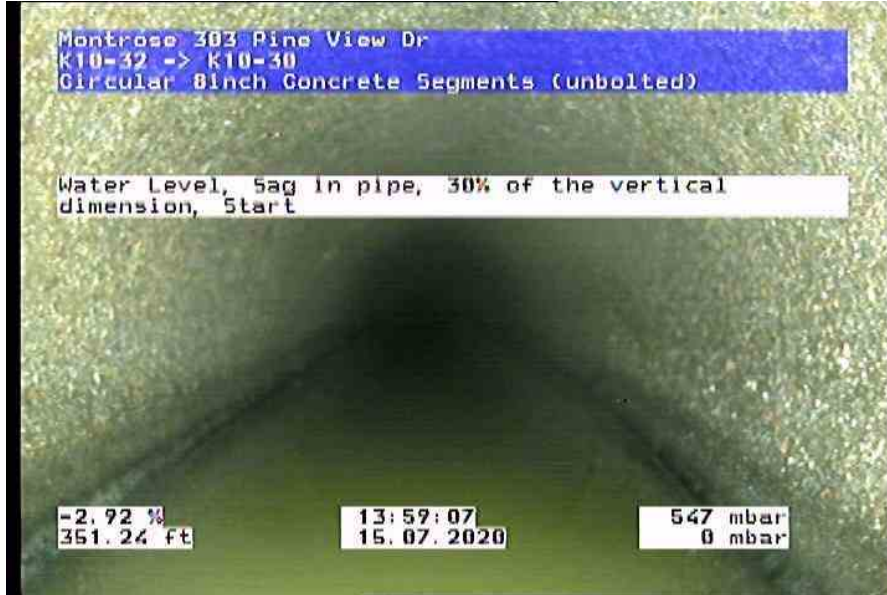
2228\_92337048-dfb6-4be7-b115-46b82867cd3f\_20200715\_140431\_314.jpg, 00:28:40, 351.24ft  
Water Level, Sag in pipe, 30% of the vertical dimension, Start

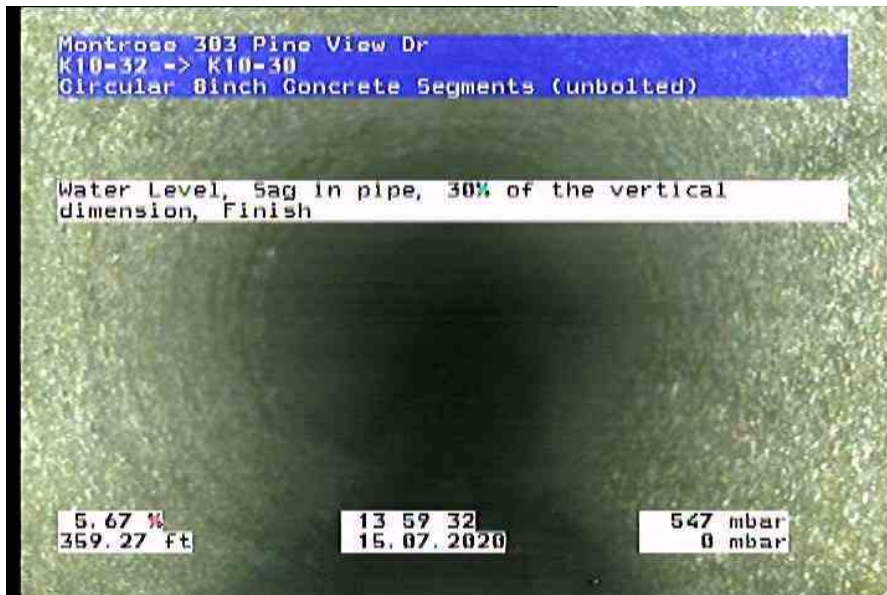
2228\_2be6c9c7-9d32-4617-8c23-442fe37856e7\_20200715\_140457\_288.jpg, 00:29:21, 359.27ft  
Water Level, Sag in pipe, 30% of the vertical dimension, Finish

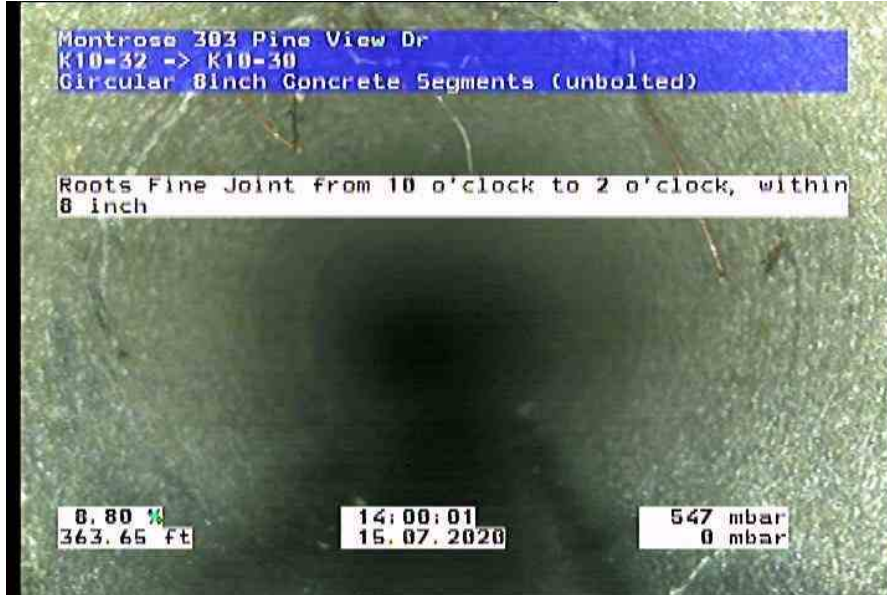
2228\_9a07a94a-6273-426a-a1f7-0255191898c6\_20200715\_140525\_848.jpg, 00:29:49, 363.65ft  
Roots Fine Joint from 10 o'clock to 2 o'clock, within 8 inch
