## Inspection report

## Section Pictures - 7/31/2020 - 1740

City	Street	Date	Pipe Segment Reference	Nr.
Montrose	114 Vista View	7/31/2020	1740	4

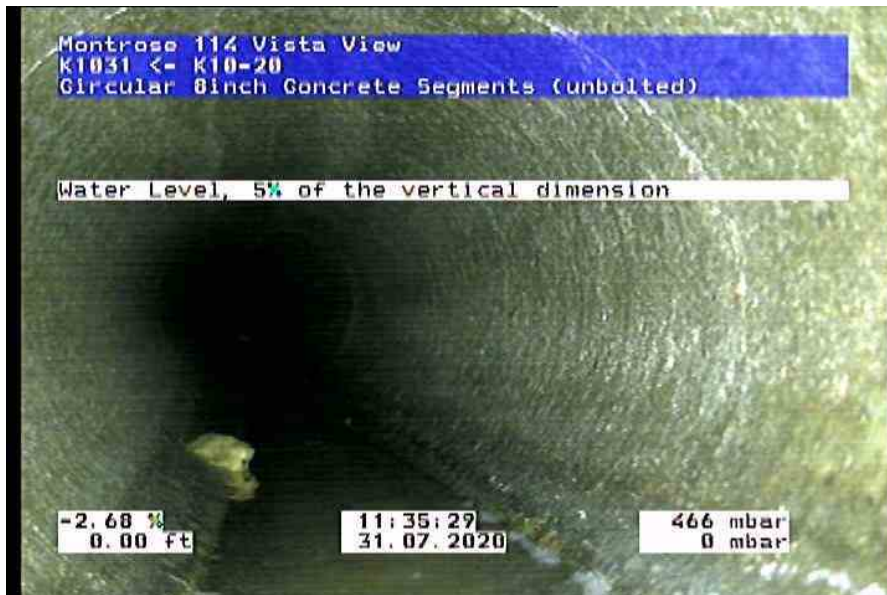
1740\_3e526944-2a83-4d7d-8081-6a0f6ebf665b\_20200731\_114054\_590.jpg,00:00:17,0.00ft Water Level, 5% of the vertical dimension

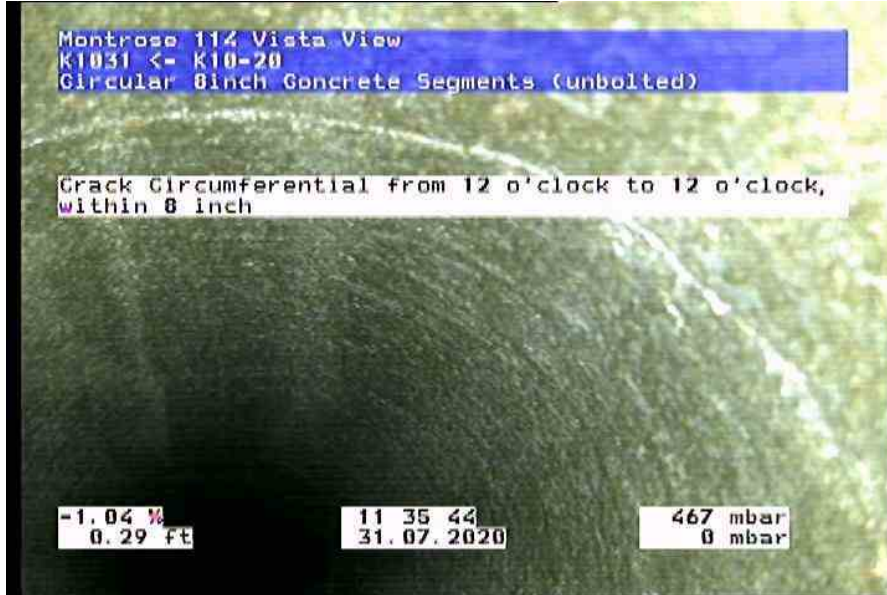
0.29	CC	Crack Circumferential from 12 o'clock to 12 o'clock, within 8 inch	00:00:32		S1
	24.04	TBD	Tap Break-In Defective at 2 o'clock, 4inch dim / RMC	00:01:38		M3

1740\_57650a6e-aed2-4519-8570-5ae3f6a75886\_20200731\_114109\_591.jpg, 00:00:32, 0.29ft  
Crack Circumferential from 12 o'clock to 12 o'clock, within 8 inch

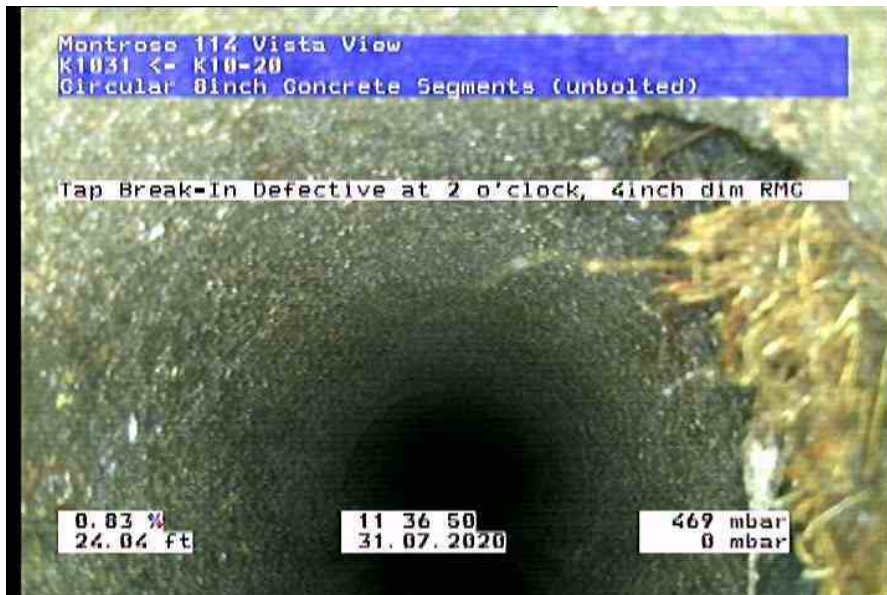
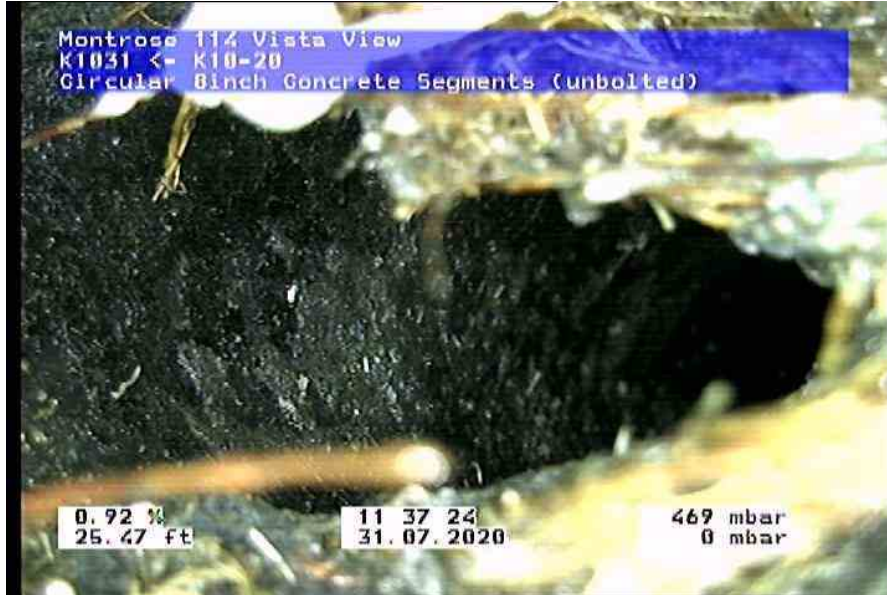
1740\_400529b0-4bd0-4ec7-acd2-d002d2e4ddae\_20200731\_114215\_191.jpg, 00:01:38, 24.04ft  
Tap Break-In Defective at 2 o'clock, 4inch dim

1740\_b090610c-e417-44db-9cde-c99883c57729\_20200731\_114249\_747.jpg, 00:01:38, 24.04ft  
Tap Break-In Defective at 2 o'clock, 4inch dim

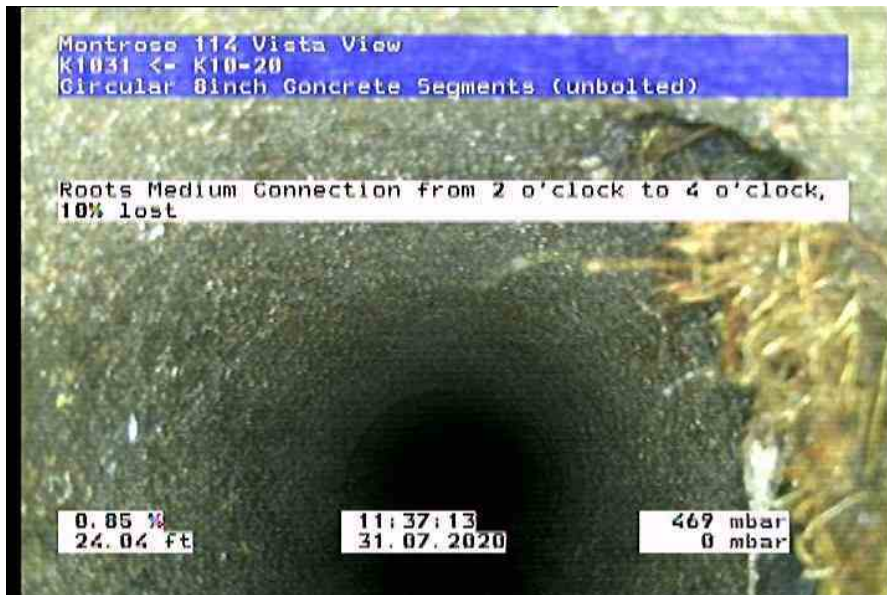
24.04	RMC	Roots Medium Connection from 2 o'clock to 4 o'clock, 10% lost	00:02:01		M3
	41.13	TS	Tap Saddle at 9 o'clock, 4inch dim	00:03:08		
	81.54	TB	Tap Break-In at 2 o'clock, 4inch dim, within 8 inch	00:04:28

1740\_4d2091e4-55e2-4518-aa77-99157149a435\_20200731\_114238\_879.jpg, 00:02:01, 24.04ft  
Roots Medium Connection from 2 o'clock to 4 o'clock, 10% lost

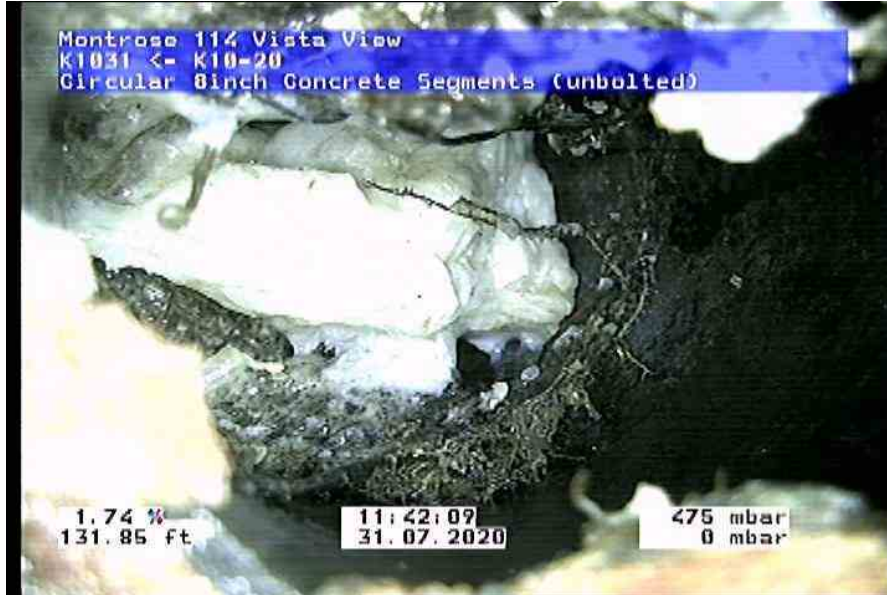
1740\_808e9b22-5b71-4ce9-bee7-baaa419aa1be\_20200731\_114734\_727.jpg, 00:06:20, 130.82ft  
Tap Break-In Defective at 10 o'clock, 4inch dim

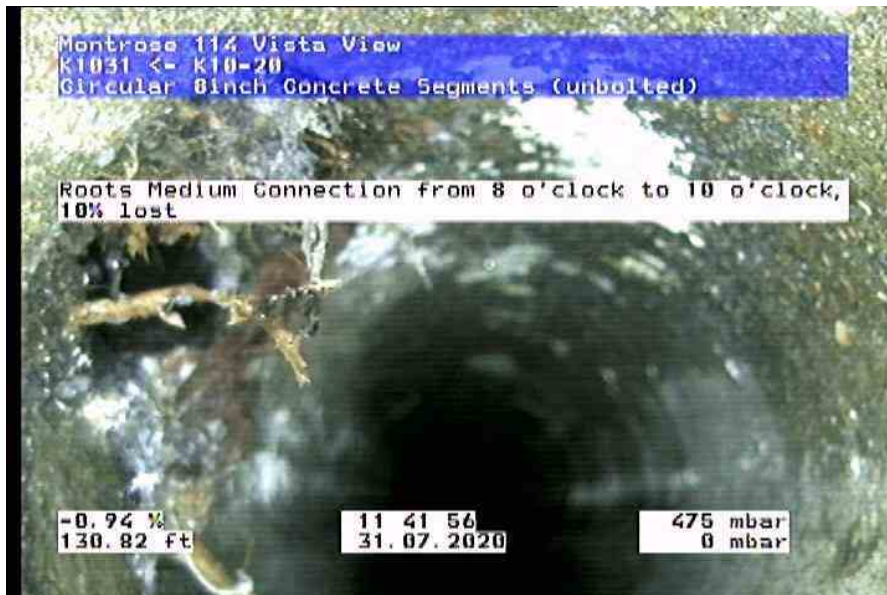
1740\_1bc0e31e-707f-4342-b6b2-33716877f06e\_20200731\_114722\_096.jpg, 00:06:45, 130.82ft  
Roots Medium Connection from 8 o'clock to 10 o'clock, 10% lost

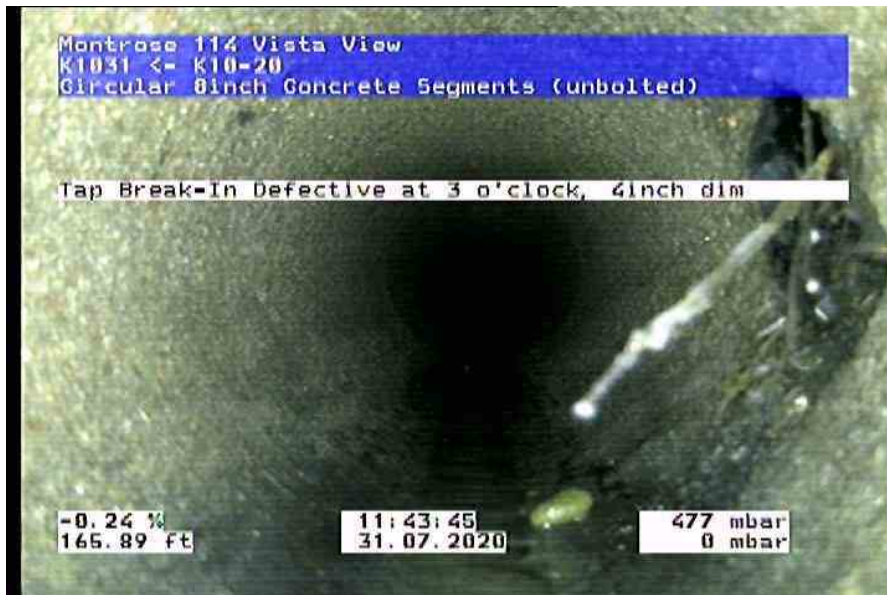
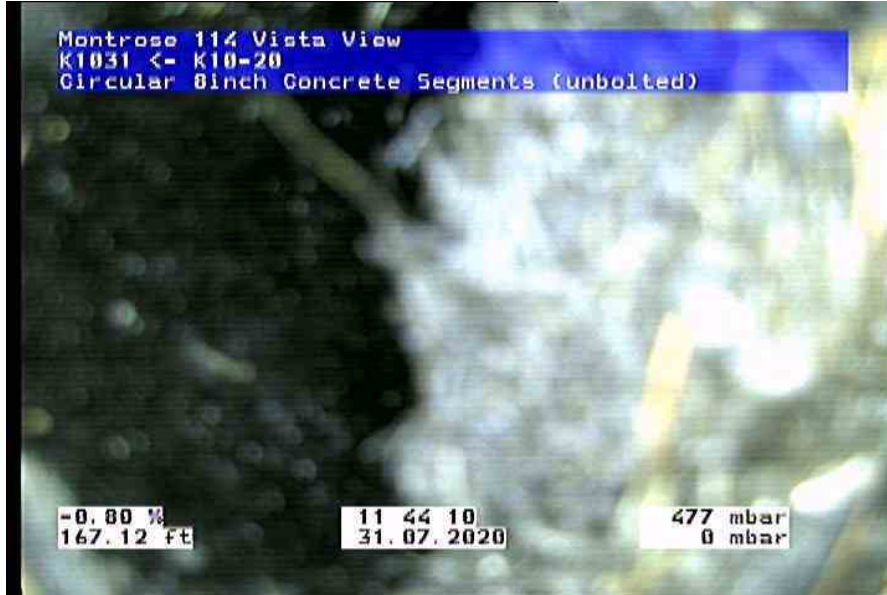
1740\_91869521-bbe6-4073-b03d-7585c0b0f748\_20200731\_114910\_934.jpg, 00:08:33, 165.89ft  
Tap Break-In Defective at 3 o'clock, 4inch dim

1740\_3f4a5f8d-6ae9-4816-bcb0-356b424b5023\_20200731\_114935\_939.jpg, 00:08:33, 165.89ft  
Tap Break-In Defective at 3 o'clock, 4inch dim

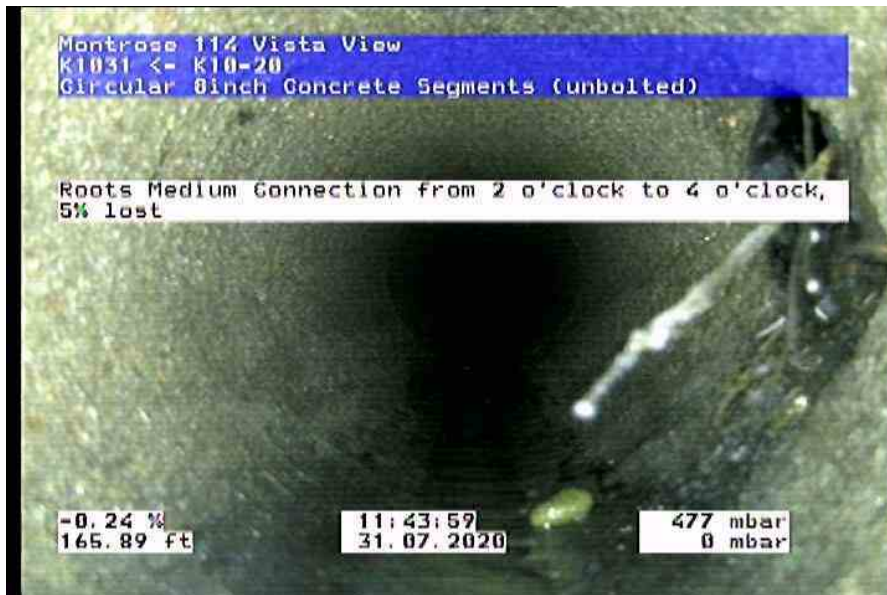
1740\_50303b2d-e142-4060-966d-4505c76047c1\_20200731\_114924\_424.jpg, 00:08:47,  
165.89ft  
Roots Medium Connection from 2 o'clock to 4 o'clock, 5% lost

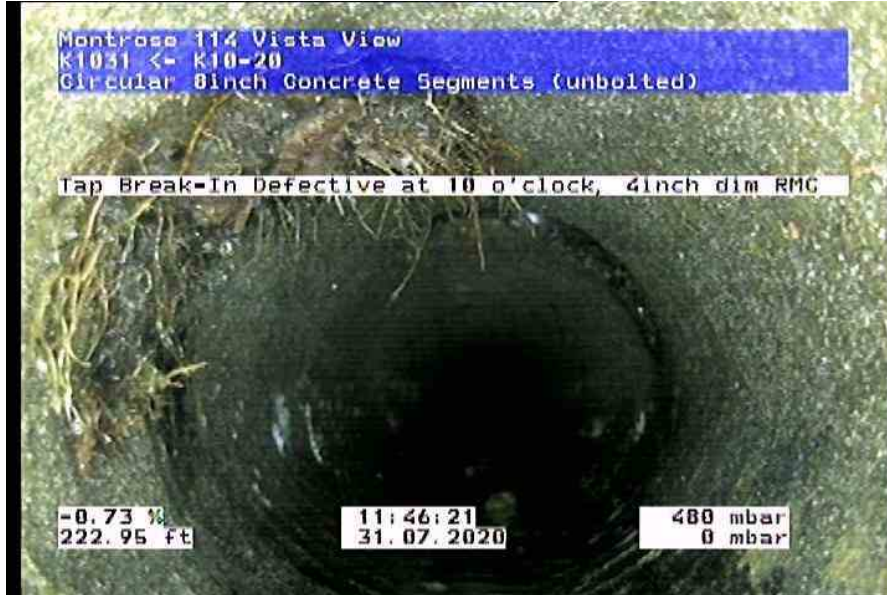
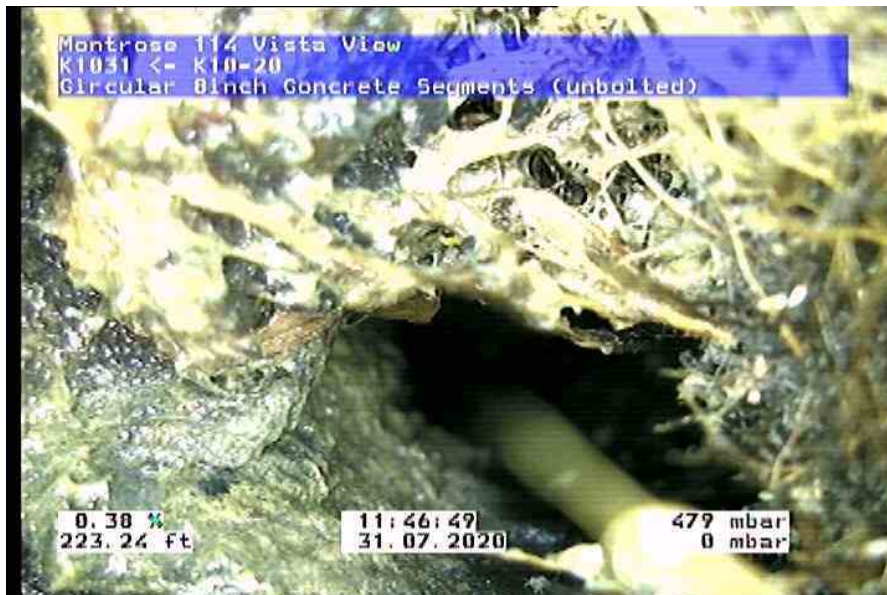
1740\_e6c8afd0-1eb7-4964-936e-167ff9fbae09\_20200731\_115146\_314.jpg, 00:11:09, 222.95ft  
Tap Break-In Defective at 10 o'clock, 4inch dim

1740\_dc919156-5063-46a6-aa2f-73c7b2333f3f\_20200731\_115214\_428.jpg, 00:11:09, 222.95ft  
Tap Break-In Defective at 10 o'clock, 4inch dim

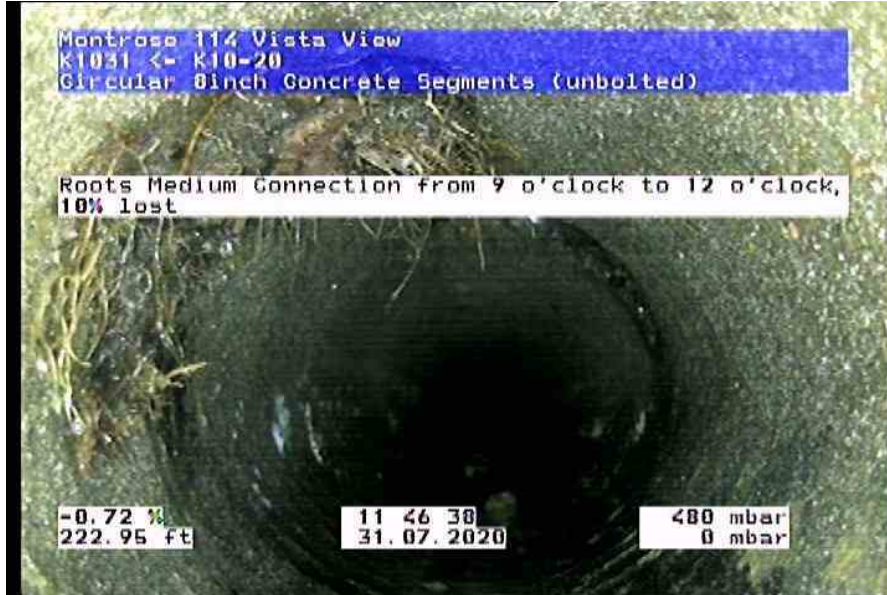
1740\_27860731-f72f-46f4-9e8a-c8545b8c2357\_20200731\_115203\_925.jpg, 00:11:26, 222.95ft  
Roots Medium Connection from 9 o'clock to 12 o'clock, 10% lost
