Inspection report

Date: 7/31/2020	Work Order:	Weather:	Surveyed By: Thomas Whitby	Certificate Number: U-217-07006886	Pipe Segment Ref.: 1755
Year laid:	Pre-cleaning:	Direction: Upstream	Pipe Joint Length:	Total Length: 120.8'	Length Surveyed: 120.8'

City: Montrose	Drainage Area:	Upstream MH: K10-21
Street: 324 Pine View	Media Label:	Up Rim to Invert: 0.0
Location Code:	Flow Control:	Downstream MH: K10-22
Location Details:	Sheet Number:	Down Rim to Invert: 0.0
Pipe shape: Circular	Sewer Use:	Total gallons used: 0.0
Pipe size: 8"	Sewer Category: SEC	Joints passed: 0
Pipe material: Concrete Segments (unbolted)	Purpose:	Joints failed: 0
Lining Method:	Owner:

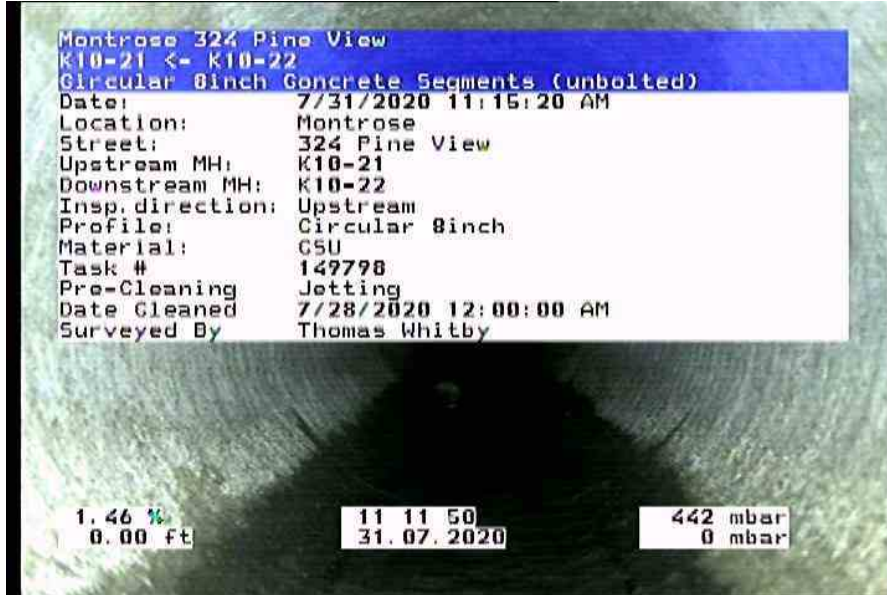
1755_51d63a4f-c6bf-4d2e-8d31-be86f216f0e4_20200731_111715_962.jpg, 00:00:07, 0.00ft Manhole

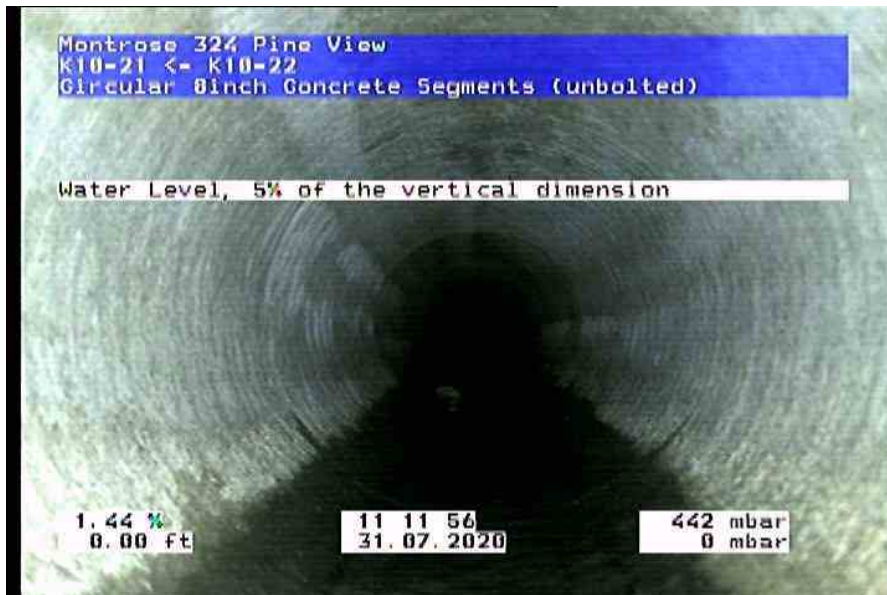
1755_1ecd5a0d-34d4-4bdb-ae17-c61ca56eb21c_20200731_111721_338.jpg, 00:00:16, 0.00ft Water Level, 5% of the vertical dimension

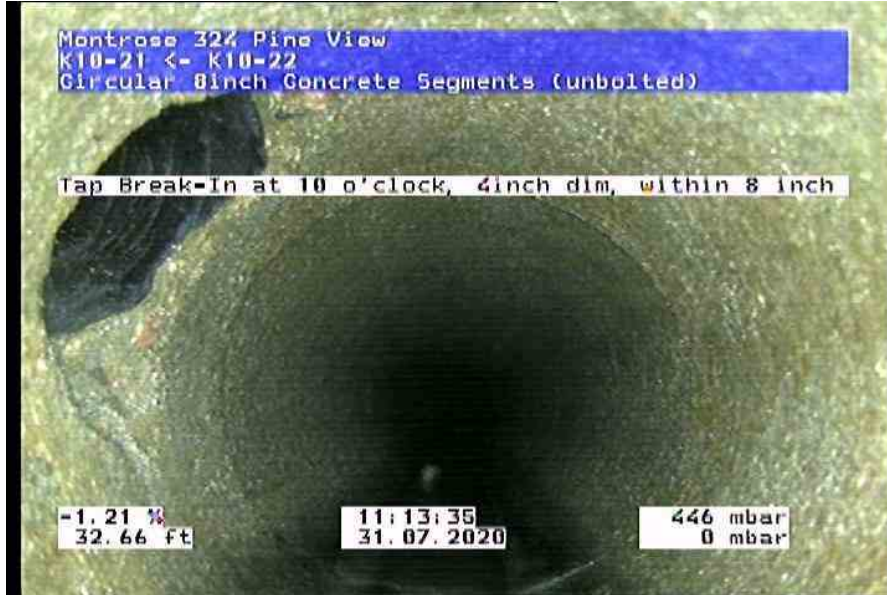
1755_5f2f19fc-ea83-495b-bdfa-cbcb9377fd16_20200731_111901_048.jpg, 00:01:54, 32.66ft
Tap Break-In at 10 o'clock, 4inch dim, within 8 inch

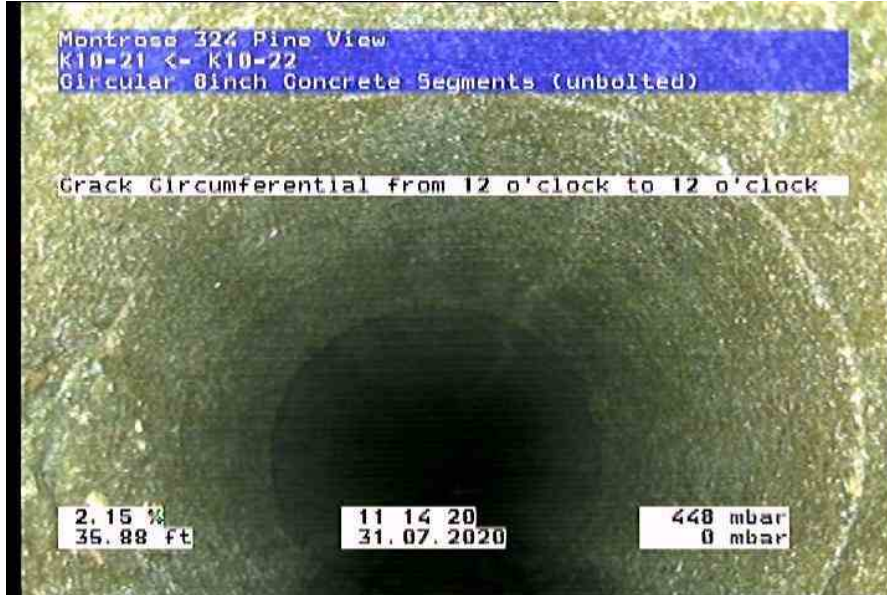
1755_7d7d11e3-55e3-495b-8616-e3906de18084_20200731_111945_875.jpg, 00:02:41, 35.88ft
Crack Circumferential from 12 o'clock to 12 o'clock

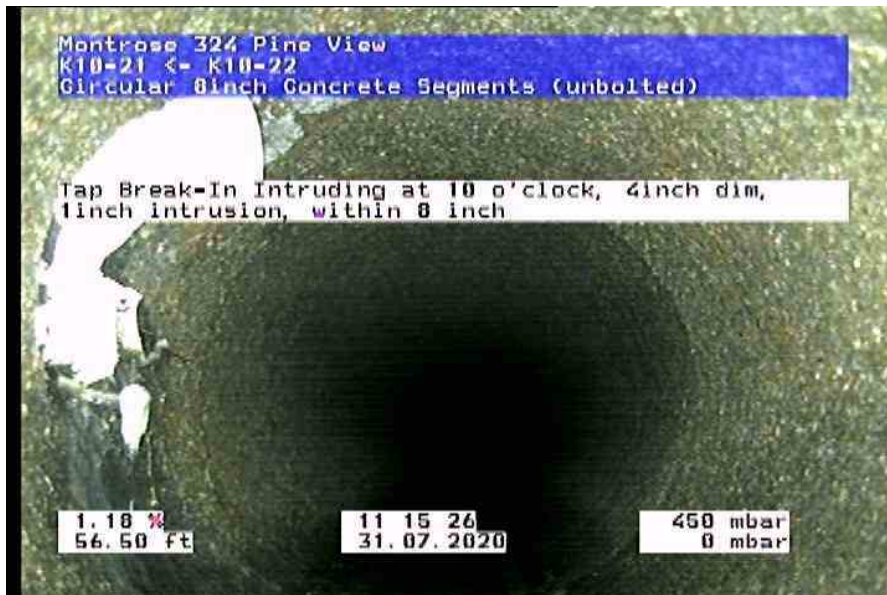
1755_dcb267e3-f7a3-4641-bc70-5714189a368a_20200731_112051_835.jpg, 00:03:47, 56.50ft
Tap Break-In Intruding at 10 o'clock, 4inch dim, 1inch intrusion, within 8 inch

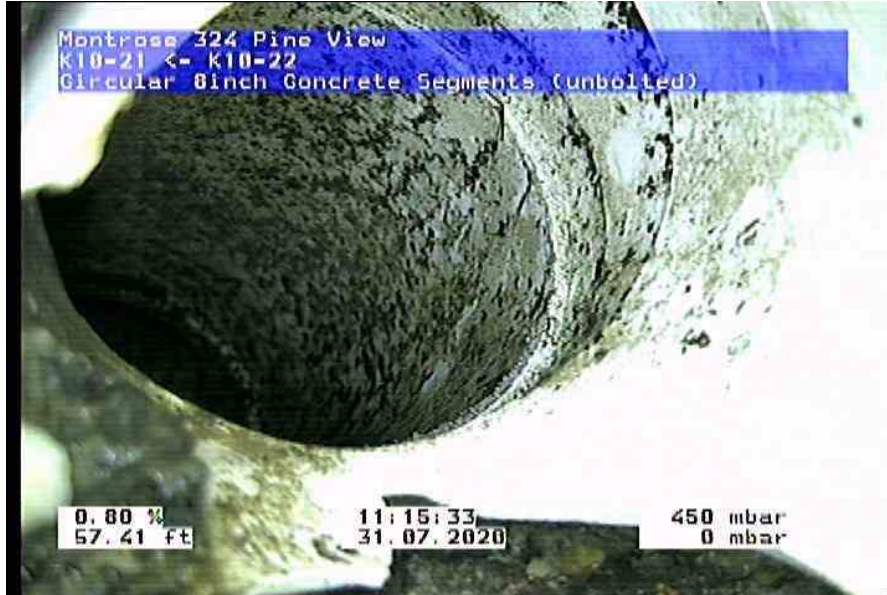
1755_0dea2bb6-0d05-4922-bf21-cfda75943ab7_20200731_112058_981.jpg, 00:03:47, 56.50ft
Tap Break-In Intruding at 10 o'clock, 4inch dim, 1inch intrusion, within 8 inch

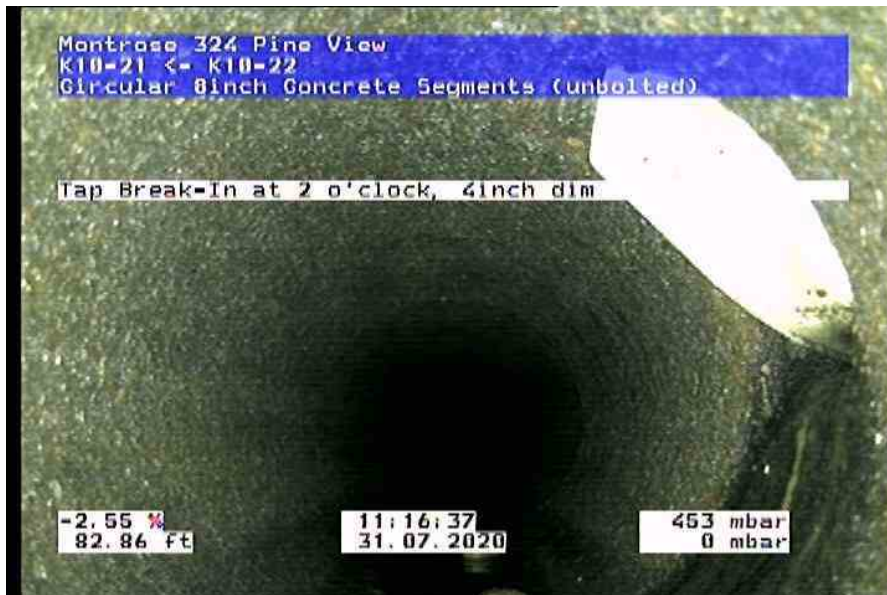
1755_db88b52a-e615-4c85-bfd9-ecc9aa972c8f_20200731_112202_541.jpg, 00:04:57, 82.86ft
Tap Break-In at 2 o'clock, 4inch dim

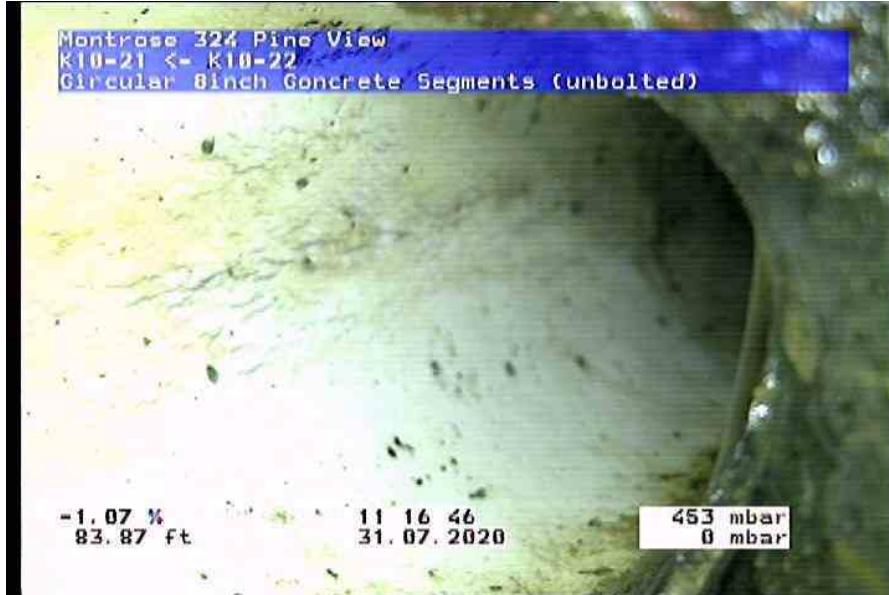
1755_bd561e51-e4de-42af-9349-f0d39c8823c1_20200731_112211_594.jpg, 00:04:57, 82.86ft
Tap Break-In at 2 o'clock, 4inch dim

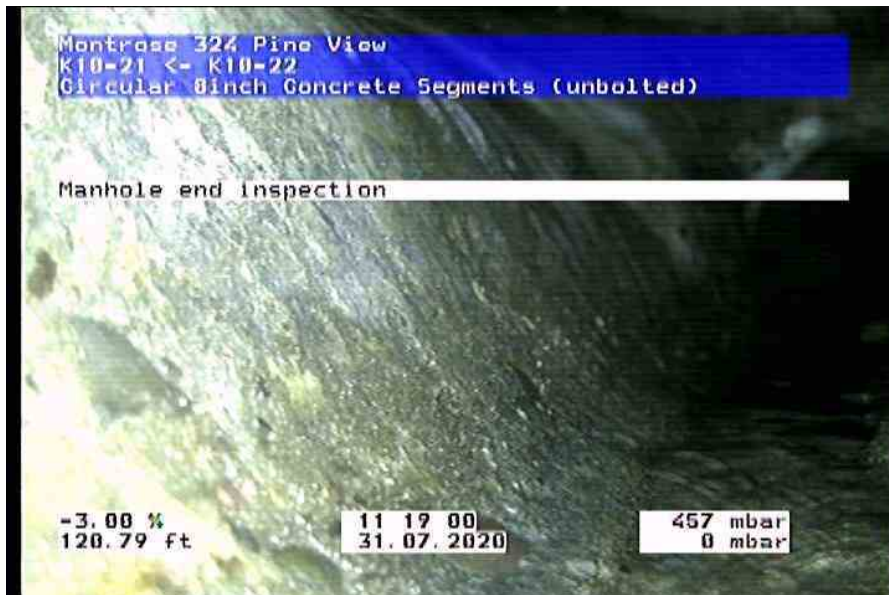
1755_0a125d37-9954-402b-b1fd-13467dfd608f_20200731_112425_278.jpg, 00:06:25, 120.79ft
Manhole
