Inspection report

Date: 7/31/2020	Work Order:	Weather:	Surveyed By: Thomas Whitby	Certificate Number: U-217-07006886	Pipe Segment Ref.: 1896
Year laid:	Pre-cleaning:	Direction: Upstream	Pipe Joint Length:	Total Length: 73.3'	Length Surveyed: 73.3'

City: Montrose	Drainage Area:	Upstream MH: K10-20
Street: 112 Vista View	Media Label:	Up Rim to Invert: 0.0
Location Code:	Flow Control:	Downstream MH: K10-21
Location Details:	Sheet Number:	Down Rim to Invert: 0.0
Pipe shape: Circular	Sewer Use:	Total gallons used: 0.0
Pipe size: 8"	Sewer Category: SEC	Joints passed: 0
Pipe material: Concrete Segments (unbolted)	Purpose:	Joints failed: 0
Lining Method:	Owner:

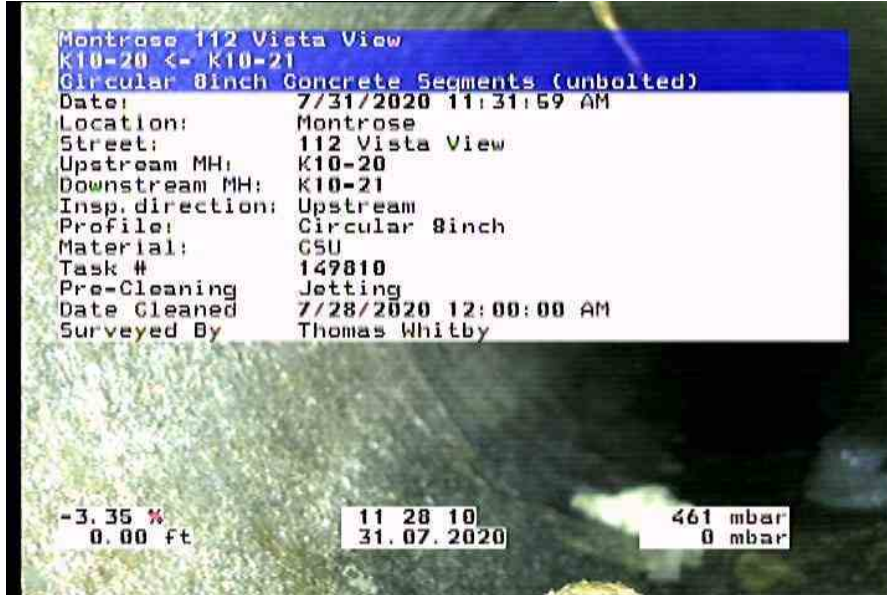
1896_99d4b4d7-7f92-4772-873f-d004e72f8f15_20200731_113335_964.jpg, 00:00:12, 0.00ft Manhole

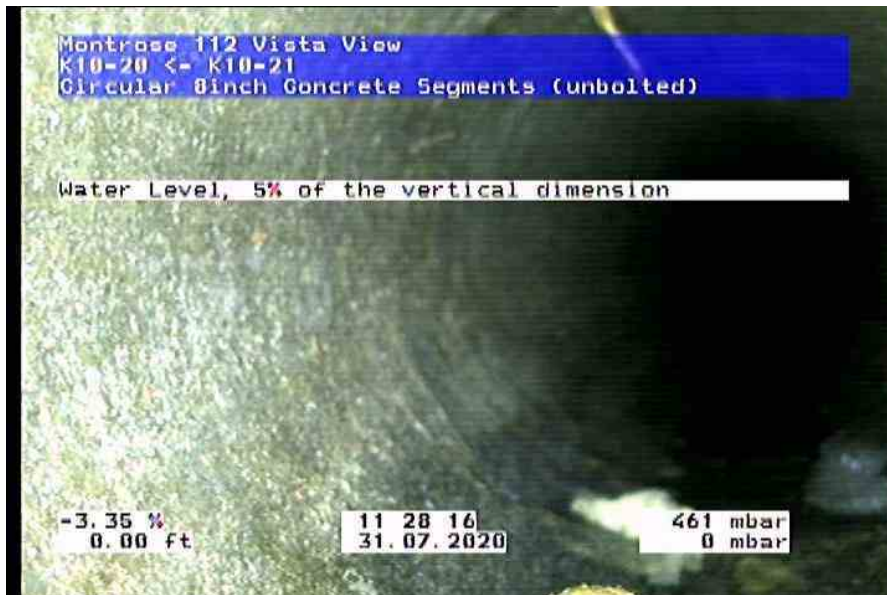
1896_474a487c-a1f2-489e-b782-a7f8d220e92a_20200731_113341_819.jpg, 00:00:23, 0.00ft Water Level, 5% of the vertical dimension

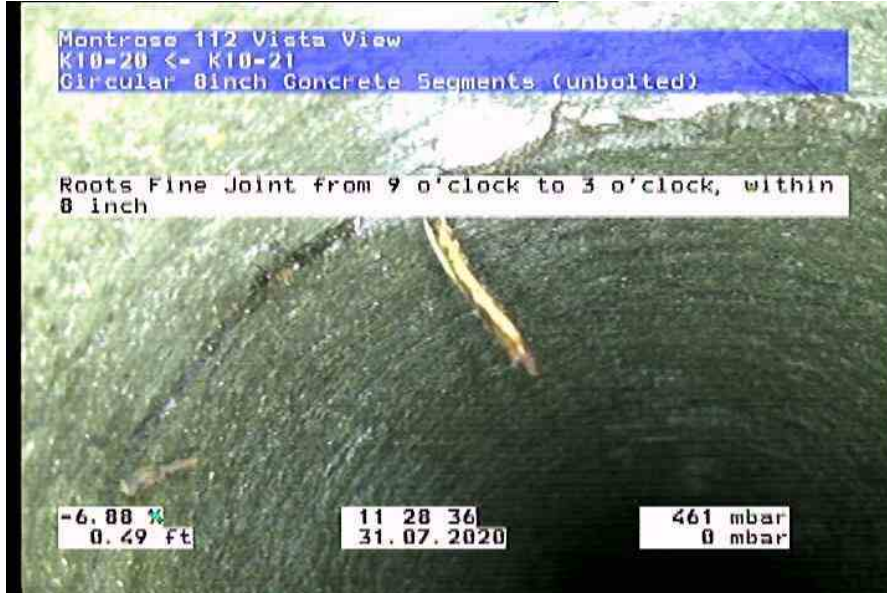
1896_b230aadb-156d-4e8d-9136-a36d90fbeat8_20200731_113401_770.jpg,00:00:43,0.49ft
Roots Fine Joint from 9 o'clock to 3 o'clock, within 8 inch

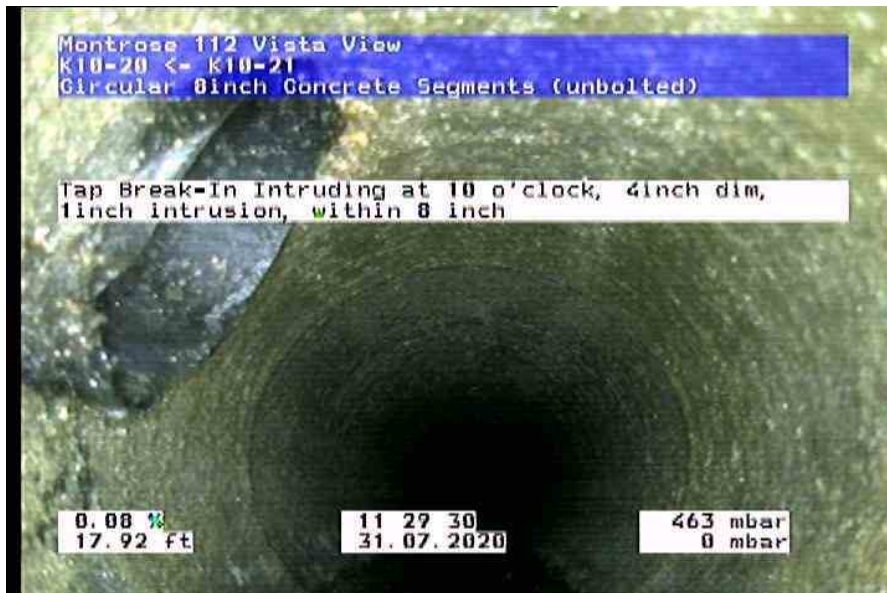
1896_f9fd0093-6589-4ab6-8125-7d4c5e019bdb_20200731_113455_152.jpg,00:01:36,17.92ft
Tap Break-In Intruding at 10 o'clock, 4inch dim, 1inch intrusion, within 8 inch

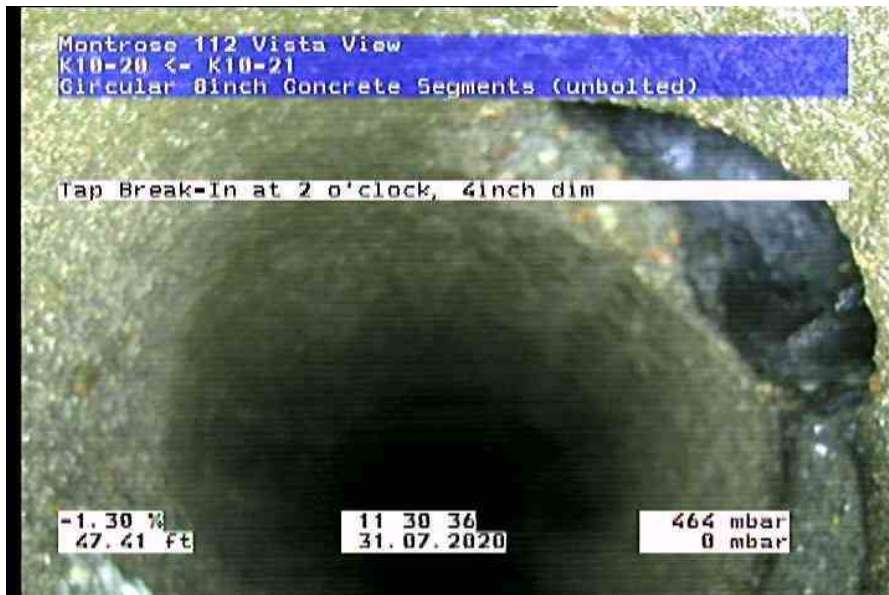
1896_883c89b6-769b-4522-bb7d-0a3f2ae19015_20200731_113601_422.jpg, 00:02:42, 47.41ft
Tap Break-In at 2 o'clock, 4inch dim

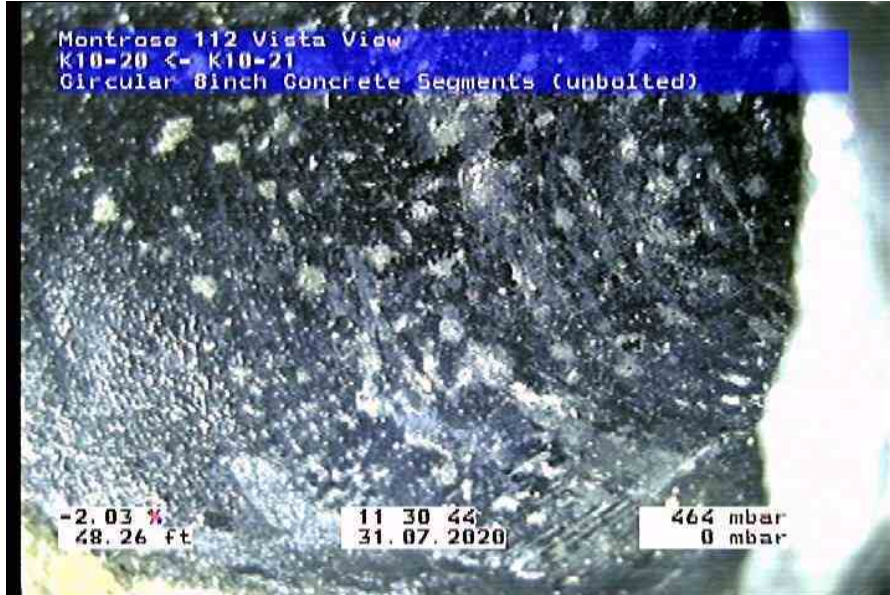
1896_a2c71ea8-a2d6-4811-856b-d41473cee6ac_20200731_113609_931.jpg, 00:02:42, 47.41ft
Tap Break-In at 2 o'clock, 4inch dim

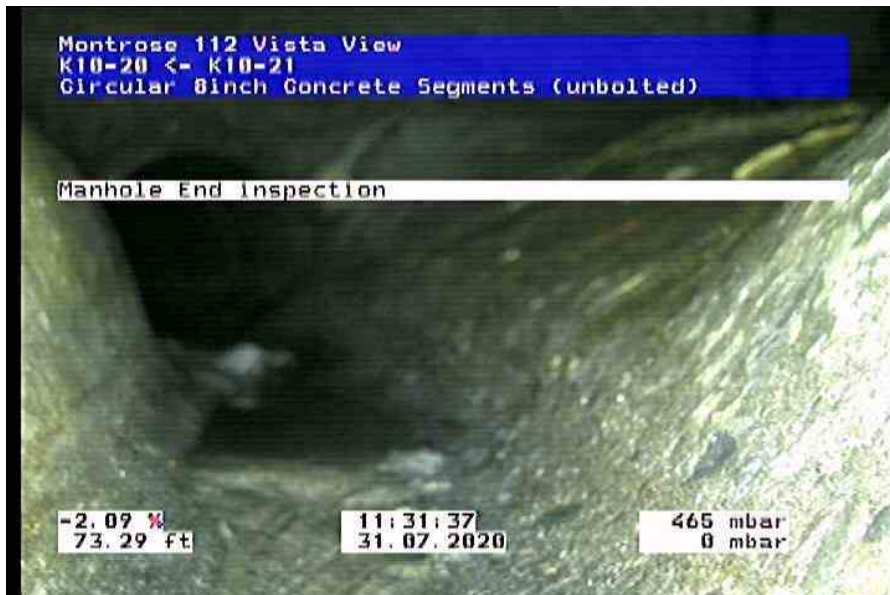
1896_ba736f81-90d9-48a1-860a-c0761a7de3ba_20200731_113703_035.jpg, 00:03:44, 73.29ft
Manhole
