Stucco Analysis Report

Denver and Rio Grande Depot
21 North Rio Grande Avenue, Montrose, CO

Report No.
SL1424-01

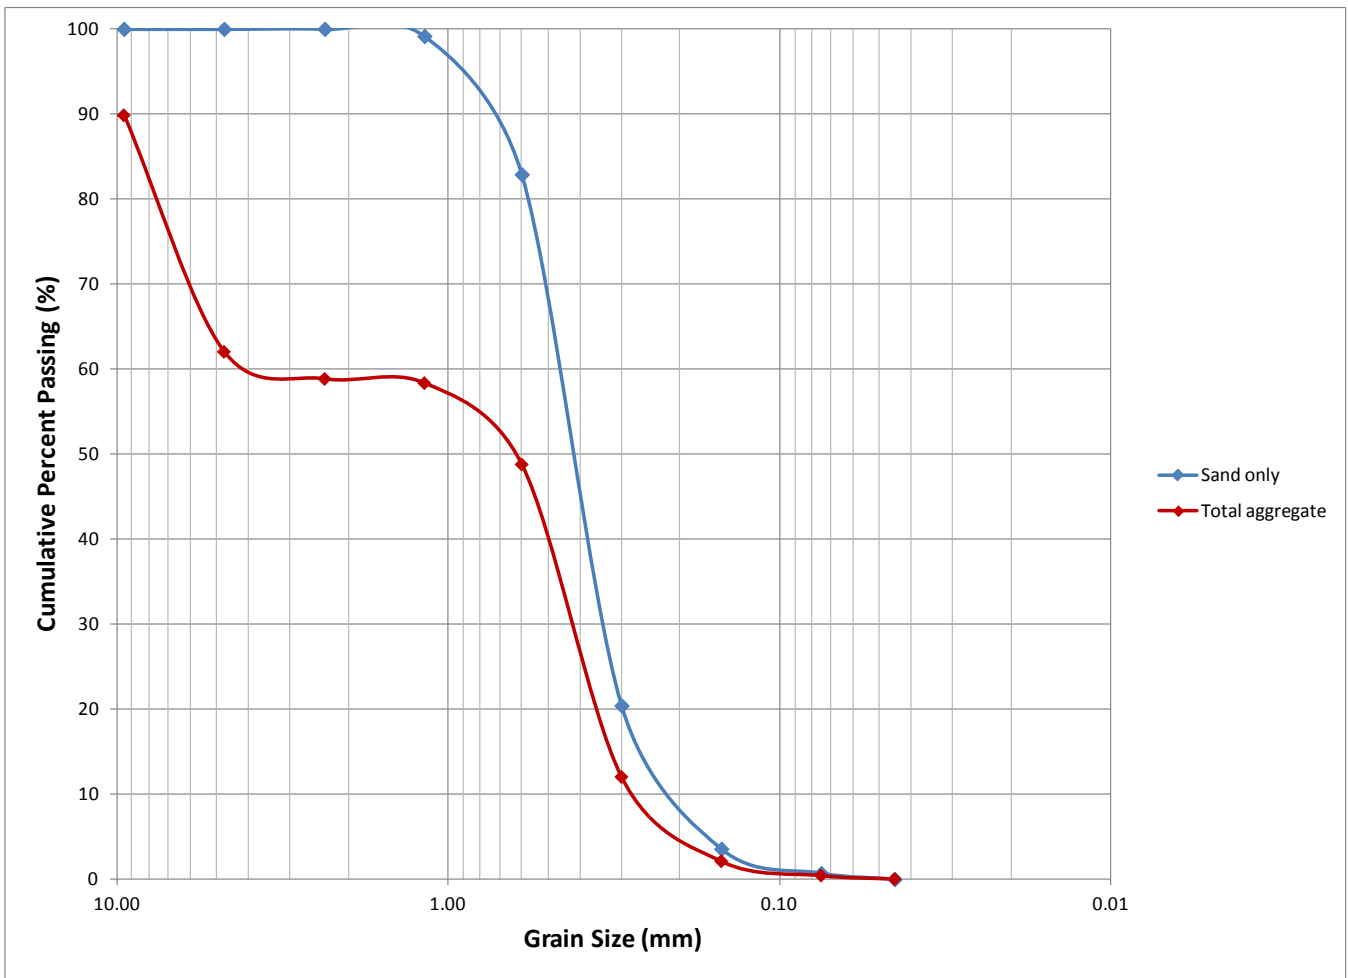
Chart 6.1: Aggregate Sieve Analysis

The following chart presents particle size distribution curves for the extracted sand samples. The chart plots the data from Tables 6.1 and 6.2. The blue curve includes only the sand while the red curve plots the total aggregate.

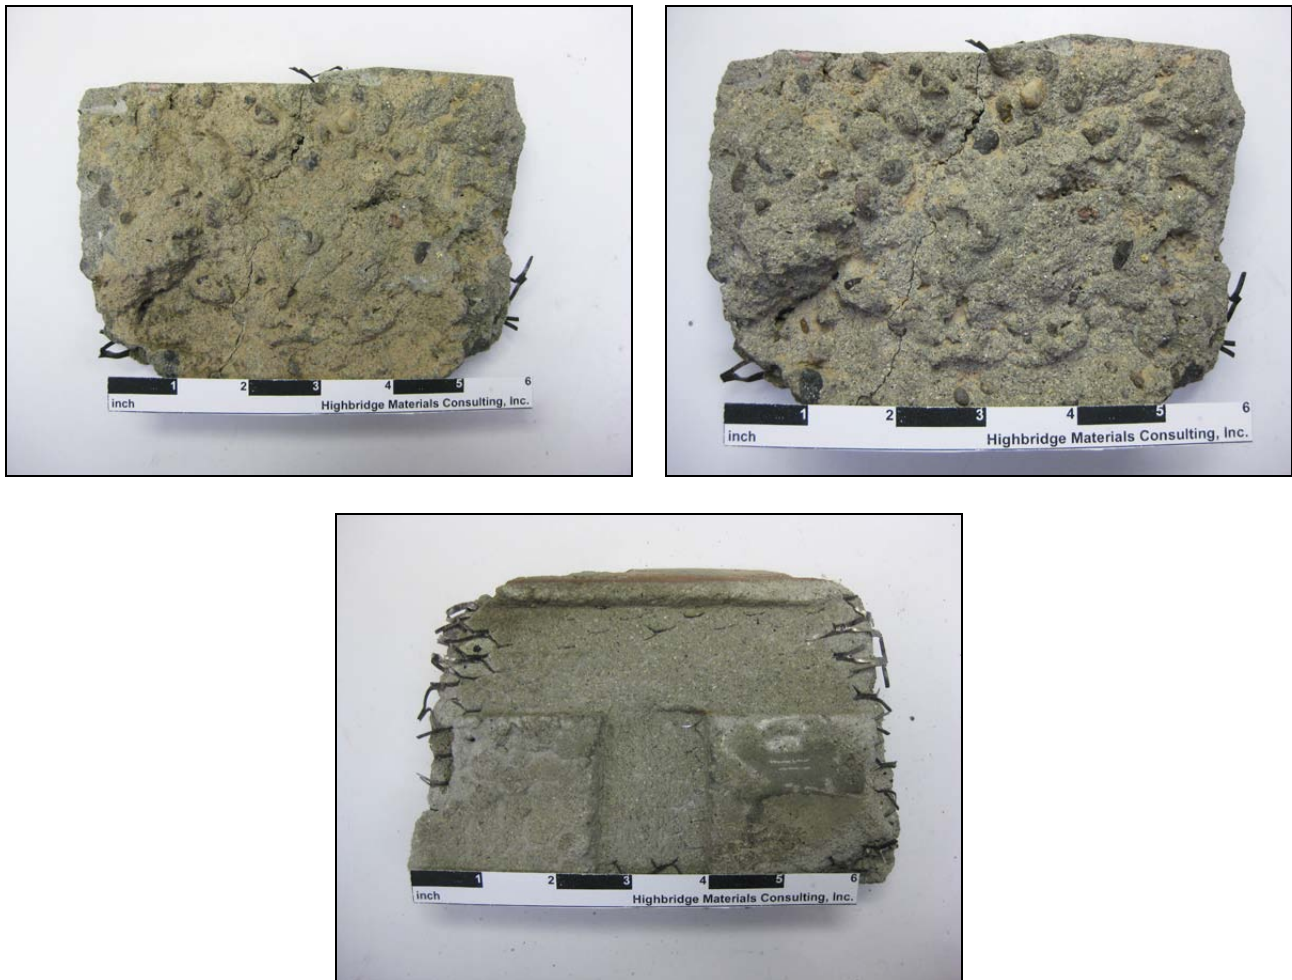
Figure 1: Photographs of the stucco sample received by Highbridge for examination. (Upper left) The outer face is shown as received. Note there is a soft, orange-toned coating covering most of the finish coat. (Upper right) The outer surface is shown after the laboratory scrubbed off the coating to reveal a weathered face with partially exposed aggregates. (Lower) The inner surface is shown. There are complete impressions of wood lath and another surface behind the lath.

The sample was received with a soft orange-toned coating thinly applied over the finish. It is not within the scope of the laboratory to determine whether this finish was original to the installation. For the sake of argument, it is assumed that the finish was applied at a later date. The original stucco finish would have had the coarse, clumpy texture apparent now. However, the aggregate grains would have been coated with a thin layer of cement paste and the entire surface would have been a uniform gray color. This assumes that the surface was left alone after dashing and there was no subsequent brushing or scrubbing of the green stucco. Whatever the case, the aggregates would have become partly exposed after a relatively short time as a result of the cement paste weathering. This may have been more prevalent in areas with greater exposure to rain or running water.

Before destroying the sample for analysis, the laboratory scrubbed the soft coating off under running water. This revealed a surface that may reflect an early appearance of the stucco if not the original one. Though the portland cement paste has carbonated, it has not developed the rich orange discoloration rind that is often observed in older products. Instead, the matrix retains a neutral gray color. Where the gravel is exposed, there is a contrasting appearance due to the darker purplish shades of the volcanic grains. As opposed to a pebble dash where gravel grains would be in close contact, the contrasting exposed gravel particles are sporadically distributed about one to three grain widths apart. Finally, sand grains are also exposed along the stucco face. From a distance, these contribute only to the overall texture of the stucco, especially under oblique lighting conditions. Up close, there is a distinctive white speckling due to the relatively high content of opaque alkali feldspar grains.

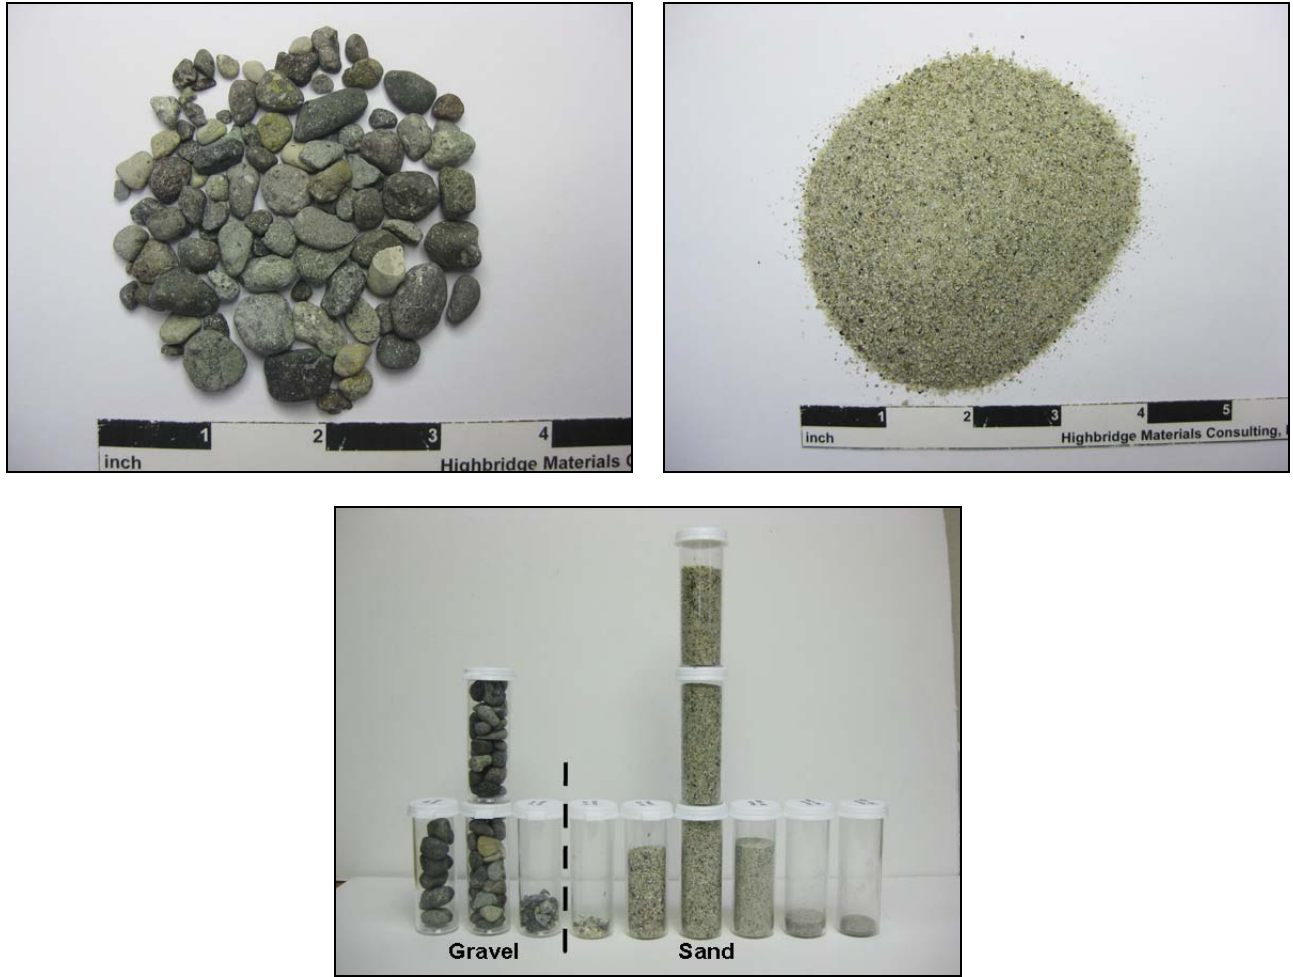
Figure 4: Photographs of the aggregate extracted through acid digestion. (Upper left) The gravel addition is shown. The volcanic particles are mostly rounded to subrounded in shape with aspects that range from equant to slightly oblate. (Upper right) The sand addition is shown. The sand is mostly uniform and light brownish gray in color. (Lower) The total aggregate is shown after gradation through a standard sieve stack. Note the distinctly bimodal distribution with a trough at around the No. 8 sieve that divides the gravel and the sand.
