## Inspection report

## Section Pictures - 7/31/2020 - 1740

City	Street	Date	Pipe Segment Reference	Nr.
Montrose	114 Vista View	7/31/2020	1740	4

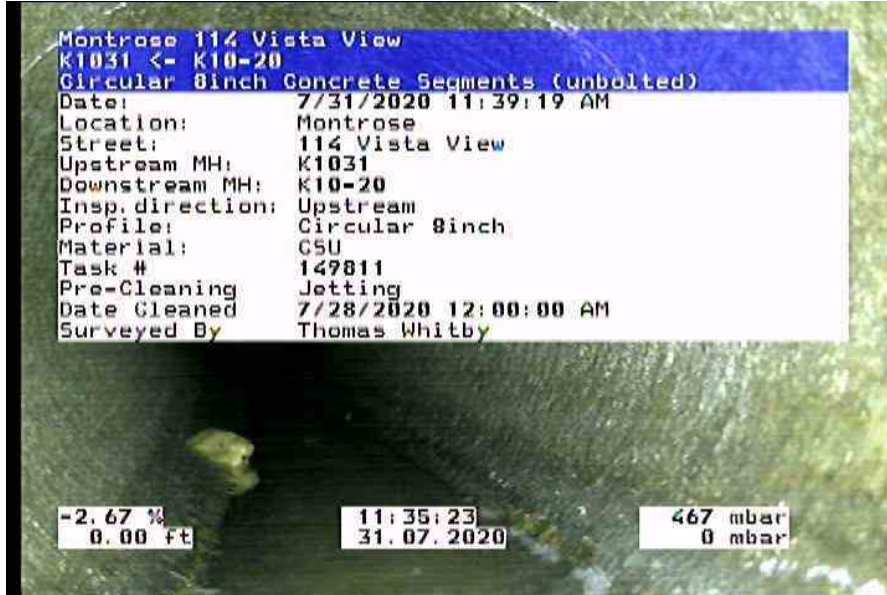
1740\_d51ccd5c-1f82-4bac-8b03-b0277ad9f8f9\_20200731\_114048\_928.jpg,00:00:09,0.00ft Manhole

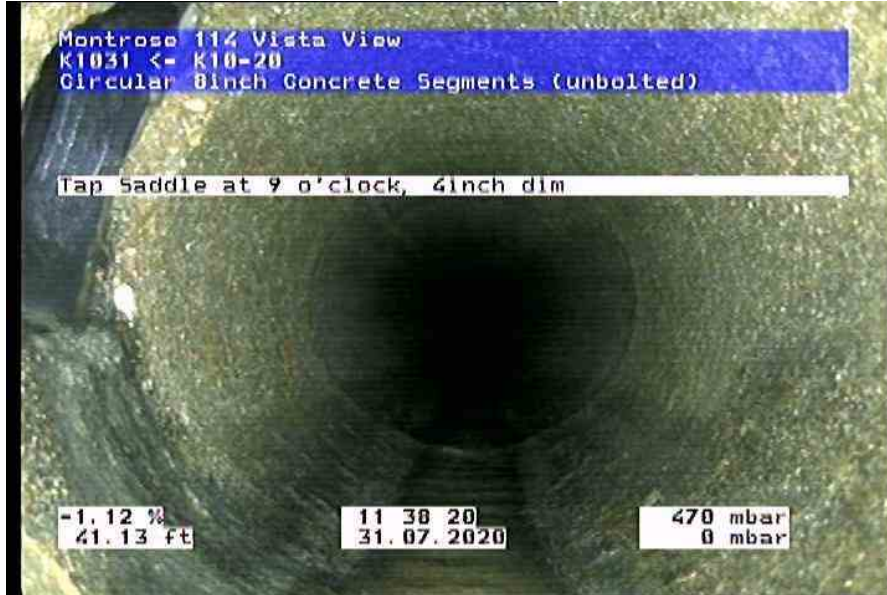
24.04	RMC	Roots Medium Connection from 2 o'clock to 4 o'clock, 10% lost	00:02:01		M3
	41.13	TS	Tap Saddle at 9 o'clock, 4inch dim	00:03:08		
	81.54	TB	Tap Break-In at 2 o'clock, 4inch dim, within 8 inch	00:04:28

1740\_aafdc0de-a642-4c30-a2cb-bb815c6b9358\_20200731\_114345\_398.jpg,00:03:08,41.13ft  
Tap Saddle at 9 o'clock, 4inch dim

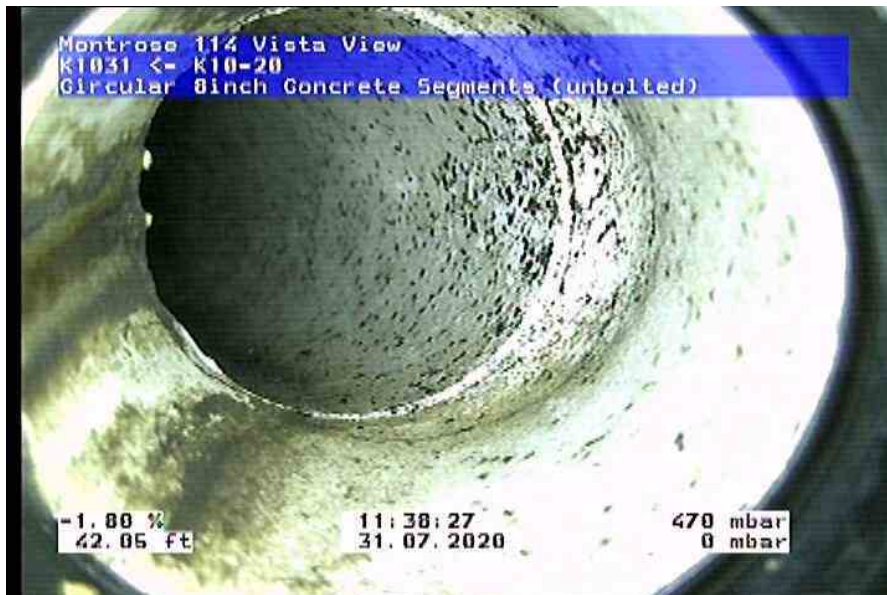
1740\_bdb178ae-7157-486d-b695-3cc774091856\_20200731\_114352\_318.jpg,00:03:08,41.13ft  
Tap Saddle at 9 o'clock, 4inch dim

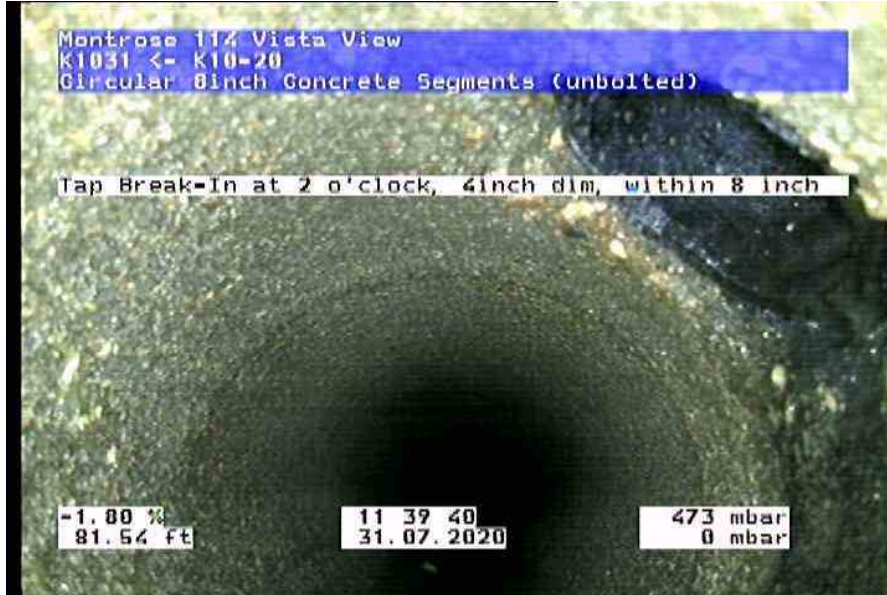
1740\_99538d55-1a2f-48fc-8950-f86a0d856b6f\_20200731\_114505\_636.jpg, 00:04:28, 81.54ft  
Tap Break-In at 2 o'clock, 4inch dim, within 8 inch

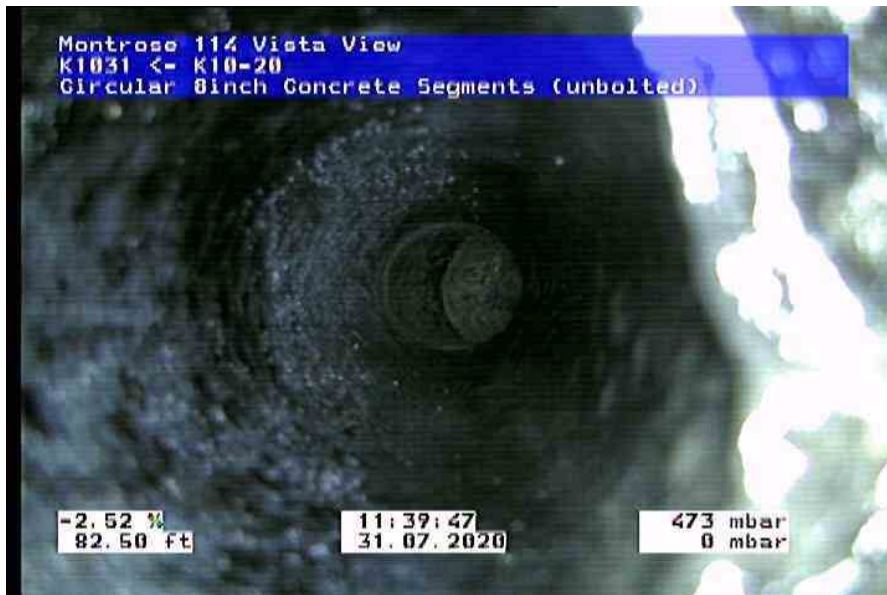
1740\_e2bdc80e-12e1-40f8-a828-a293ef7a5154\_20200731\_114512\_394.jpg, 00:04:28, 81.54ft  
Tap Break-In at 2 o'clock, 4inch dim, within 8 inch

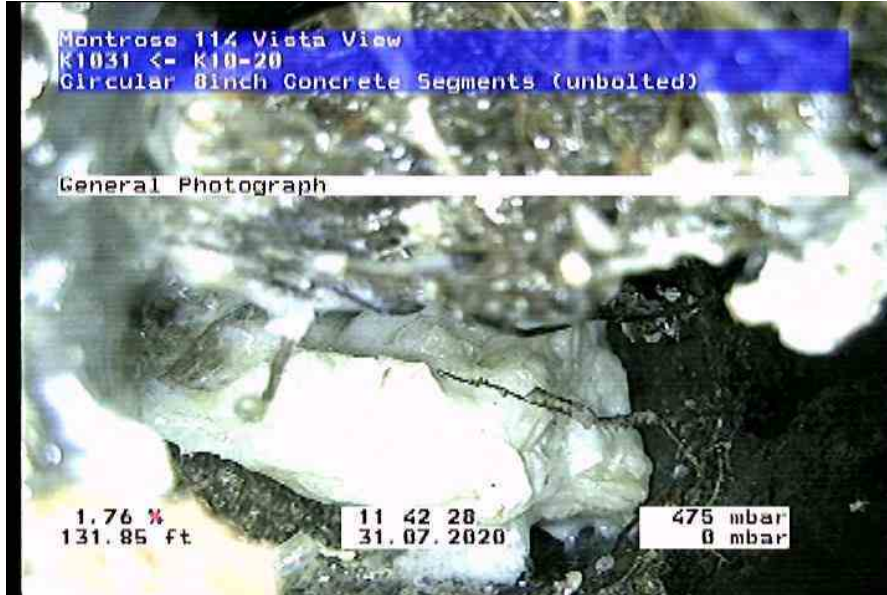
1740\_4e800c32-e11a-482f-adf5-f5db7326430f\_20200731\_114753\_574.jpg, 00:07:16, 131.85ft  
General Photograph

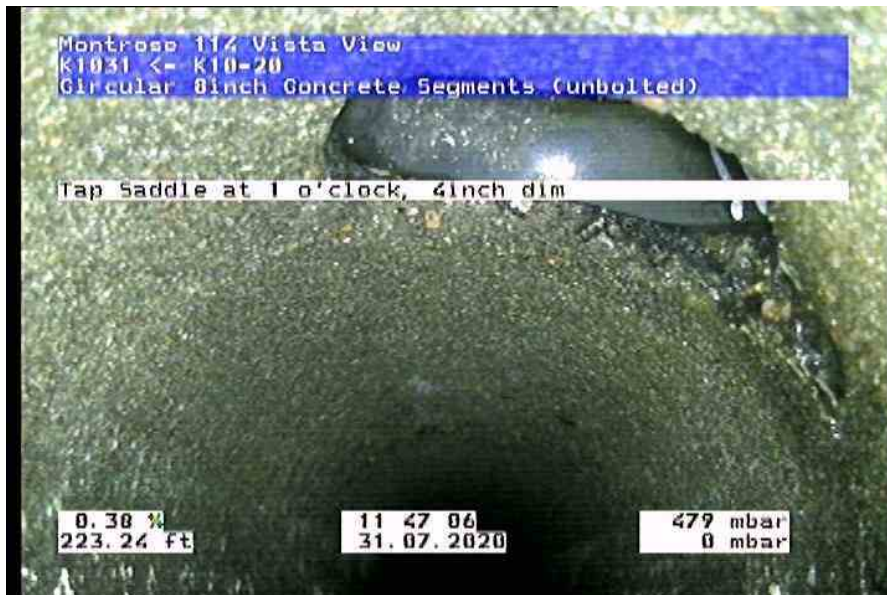
223.24	TS	Tap Saddle at 1 o'clock, 4inch dim	00:11:54		
<b>K10-31</b>	282.61	AMH	Manhole / End inspection	00:14:00

1740\_daf8c50f-a101-4076-9400-631a685e8c60\_20200731\_115231\_911.jpg, 00:11:54, 223.24ft  
Tap Saddle at 1 o'clock, 4inch dim

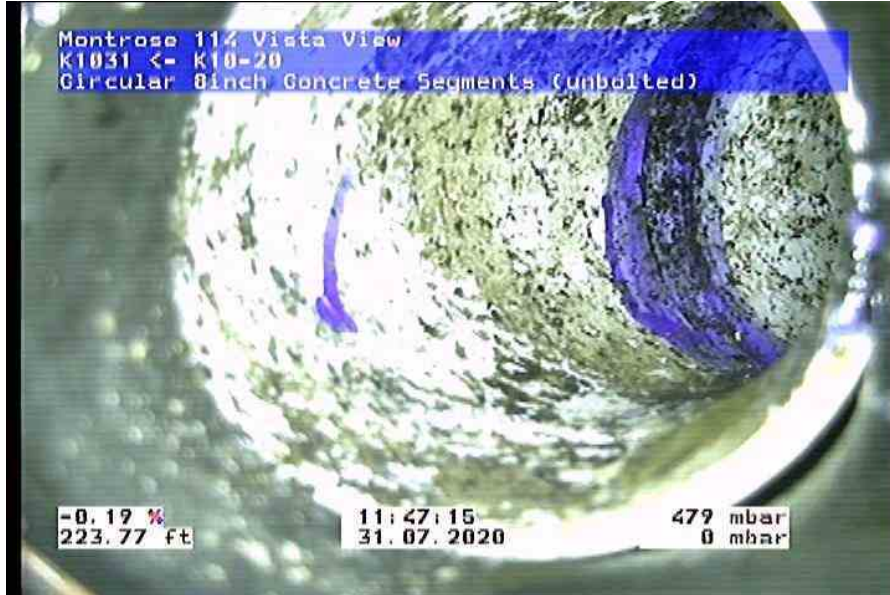
1740\_a083c924-689f-42af-9f1c-9d1d270979f4\_20200731\_115240\_341.jpg, 00:11:54, 223.24ft  
Tap Saddle at 1 o'clock, 4inch dim

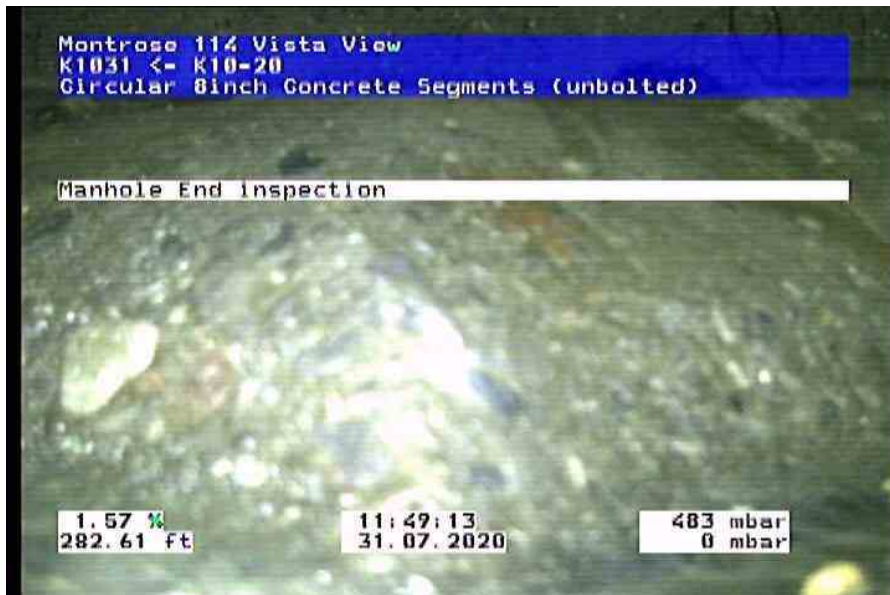
1740\_944e08c4-9650-478c-a130-b26e1a98165e\_20200731\_115438\_309.jpg, 00:14:00,  
282.61ft  
Manhole
