Inspection report

Date: 7/31/2020	Work Order:	Weather:	Surveyed By: Thomas Whitby	Certificate Number: U-217-07006886	Pipe Segment Ref.: 1755
Year laid:	Pre-cleaning:	Direction: Upstream	Pipe Joint Length:	Total Length: 120.8'	Length Surveyed: 120.8'

City: Montrose	Drainage Area:	Upstream MH: K10-21
Street: 324 Pine View	Media Label:	Up Rim to Invert: 0.0
Location Code:	Flow Control:	Downstream MH: K10-22
Location Details:	Sheet Number:	Down Rim to Invert: 0.0
Pipe shape: Circular	Sewer Use:	Total gallons used: 0.0
Pipe size: 8"	Sewer Category: SEC	Joints passed: 0
Pipe material: Concrete Segments (unbolted)	Purpose:	Joints failed: 0
Lining Method:	Owner:

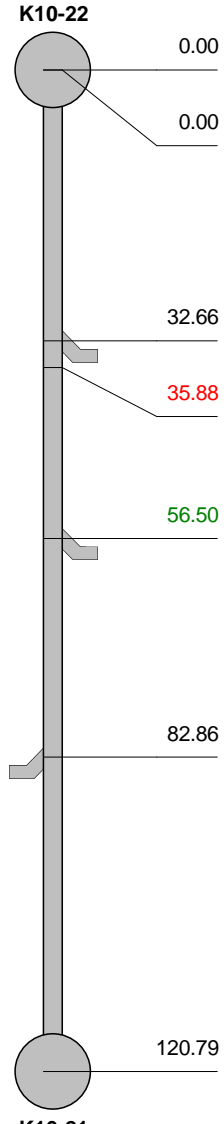
1:912	Distance	Code	Observation	Counter	Photo	Grade
K10-22	0.00	AMH	Manhole / Start inspection	00:00:07		
	0.00	MWL	Water Level, 5% of the vertical dimension	00:00:16		
	32.66	TB	Tap Break-In at 10 o'clock, 4inch dim, within 8 inch	00:01:54		
	35.88	CC	Crack Circumferential from 12 o'clock to 12 o'clock	00:02:41		S1
	56.50	TBI	Tap Break-In Intruding at 10 o'clock, 4inch dim, 1inch intrusion, within 8 inch	00:03:47		M3
	82.86	TB	Tap Break-In at 2 o'clock, 4inch dim	00:04:57		
	120.79	AMH	Manhole / end inspection	00:06:25		
K10-21
