## Tortilla Flats Structures

The following photos are of structures within the Tortilla Flats neighborhood that are candidates for reconnaissance and intensive level surveying. Jon Horn, chairperson of the City's Historic Preservation Commission, provided the photos and descriptions. Below each photograph is a number and geographical direction for reference. For example, Photo 3027, below, is a photo of homes in Tortilla Flat's northwest quadrant. Jon, who has more than 40 years of experience in his field, provided the following description of the neighborhood:

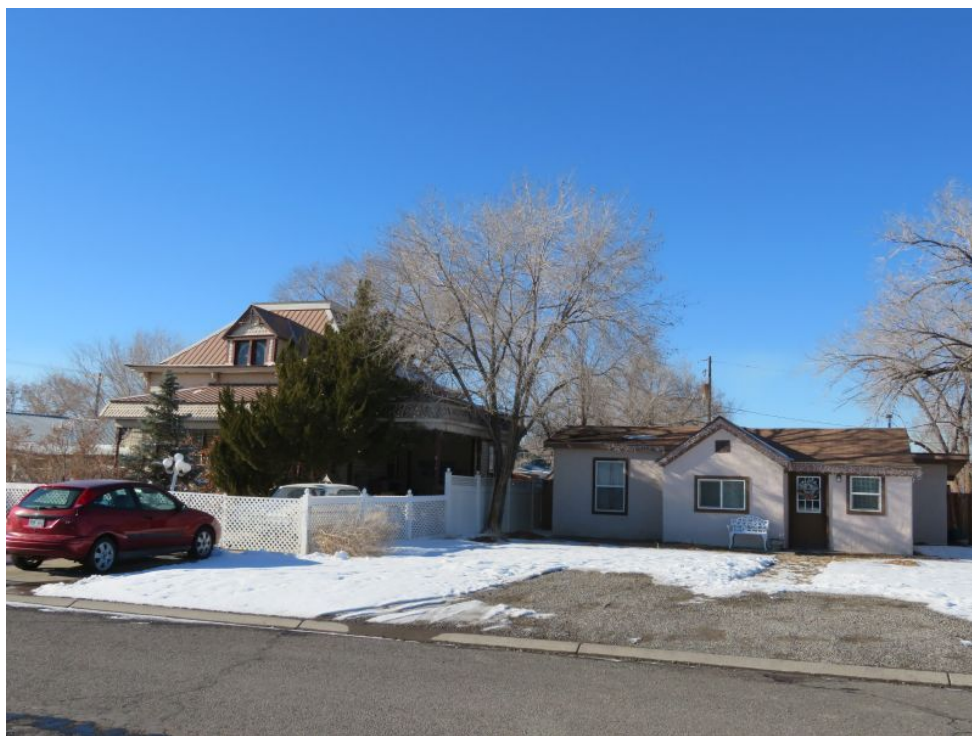
Photo 3027 Northwest

Small residence next to 1 ½-story residence on North 3<sup>rd</sup> St. between N. Ute & N. Grand.

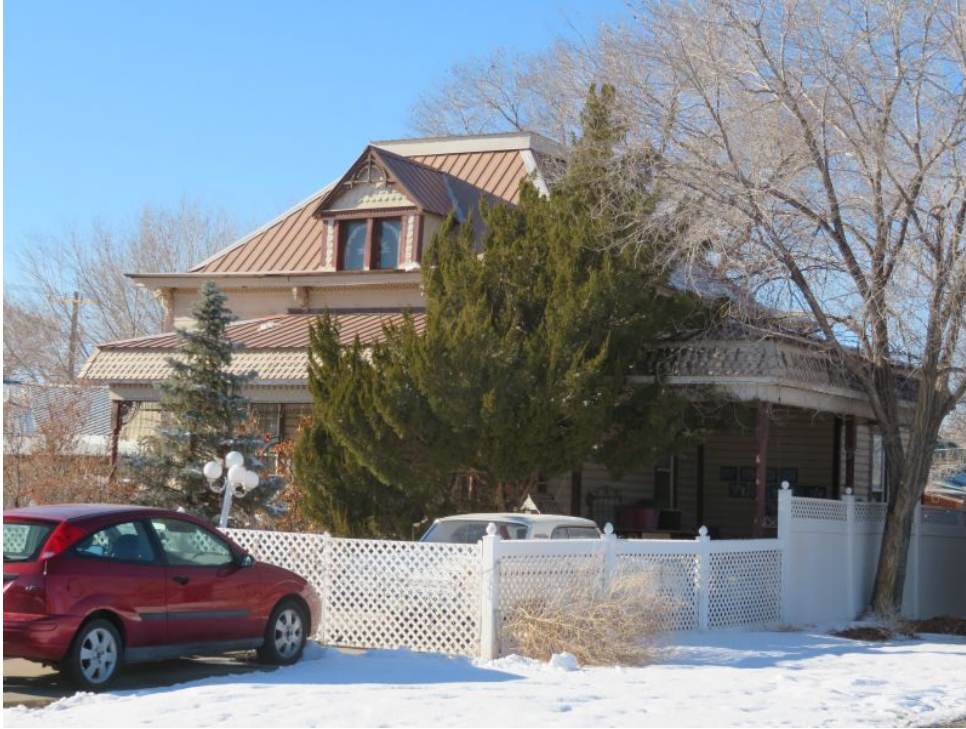
3028 Northwest

1 ½-story residence on North 3<sup>rd</sup> St. between N. Ute and N. Grand that retains Victorian elements.

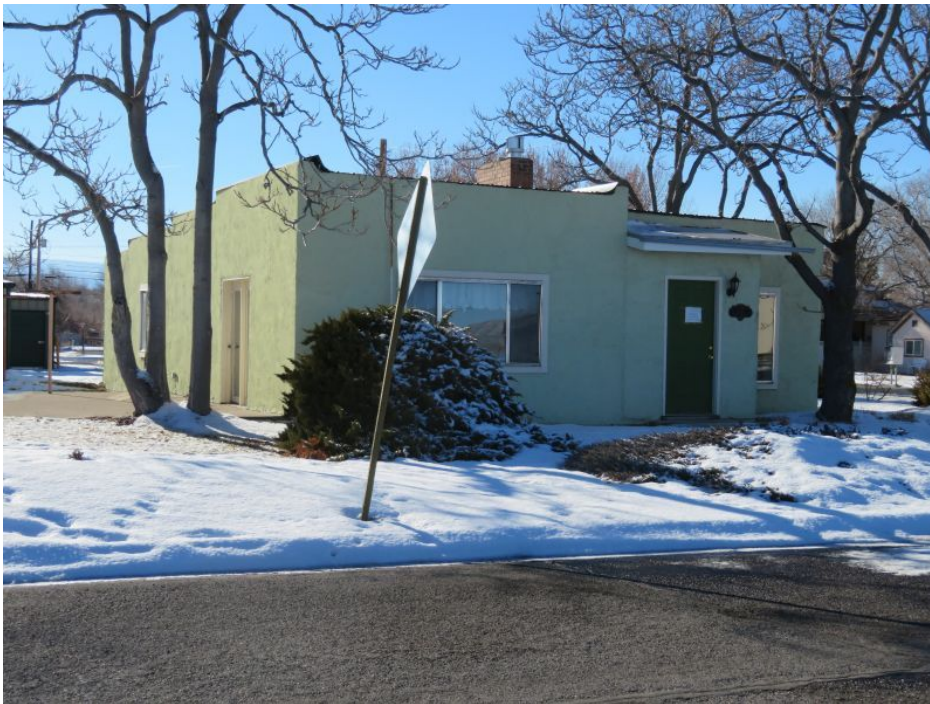
3029 West

247 Ute Avenue – Small Spanish Revival-style residence converted to business use. Not the stucco exterior and stepped parapet on the side of roof.

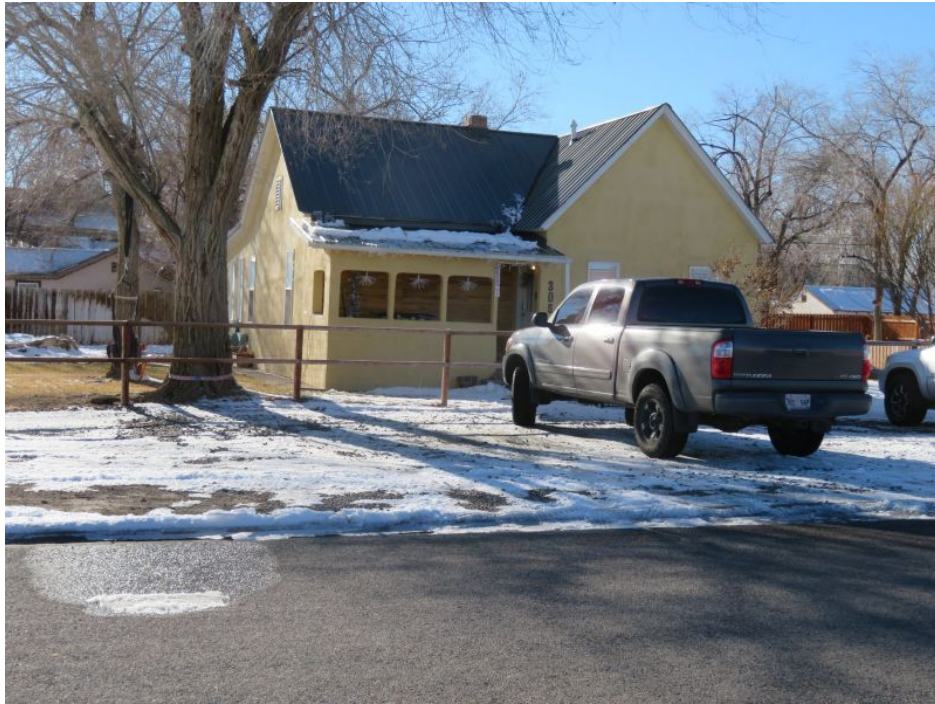
3030 West  
305 Ute Avenue – Stuccoed Gable Ell residence of early 1900s, recently remodeled.

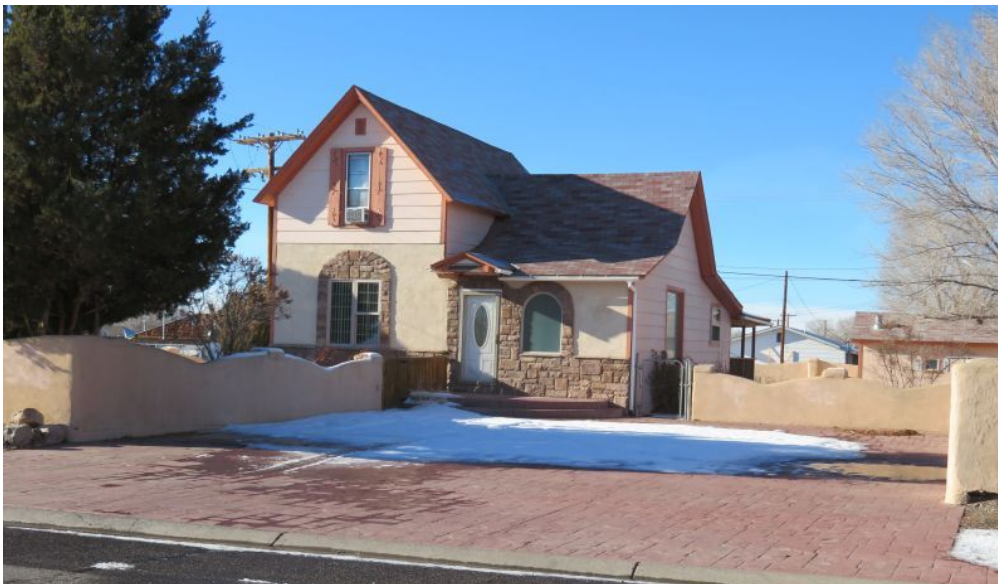
3034 West

129 North 7<sup>th</sup> St. on the corner of Grand. Remodeled 1 ½-story Gabled Ell residence with some stucco and rockwork. Note the division of outside space with stuccoed walls.

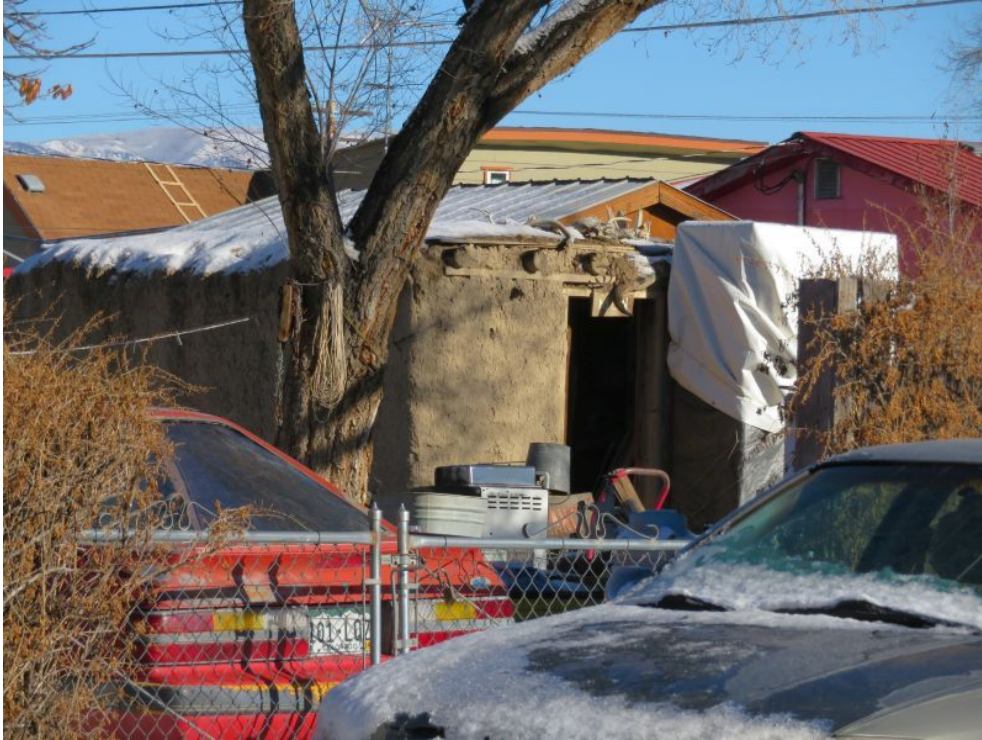
3035East

Adobe outbuilding along the alley at 840 N. Ute Ave. – Corner of Ute and 9<sup>th</sup>.

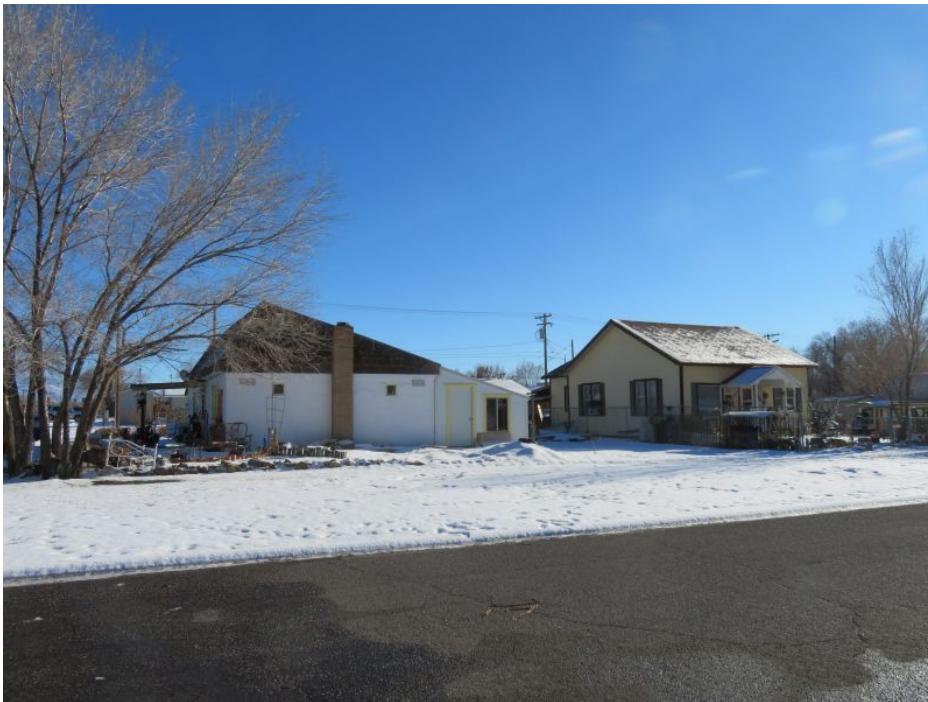
3036 South

30 8<sup>th</sup> Ave. and Corner of Ute and 8<sup>th</sup> Ave showing residences with eclectic landscaping and collection of items as yard decorations.
